Town of Yucca Valley PLANNING COMMISSION STAFF REPORT

Subject: Western Joshua Tree (WJT) Permit 030-22, 7516 Barberry Avenue, Yucca

Valley CA. APN: 0587-151-14; Encroach Within Ten (10) Feet of One (1)

NATIVE PLANT INVENTORY REPORT SITE MAP WITH PHOTOGRAPHIC CENSUS

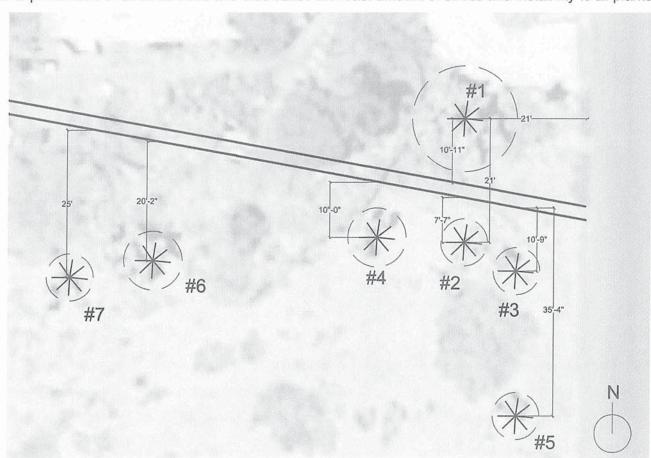
This report is for a sewer line connection at 7516 Barberry Drive Yucca, Valley CA. A native plant inventory was performed in October 2021 & January 2022 to evaluate the work area (40 ft within estimated work area) for Joshua Trees (*Yucca brevifolia* ssp. *brevifolia*), a candidate species under the California Endangered Species Act (CESA), effective October 9, 2020. There are no *Yucca schidigera* and *Juniperus californicus* affected by this work.

It is recommended to run the necessary trenching (approximately 12" wide and 3' deep) between the Joshua Trees as shown. If the trenching is run between the trees, the resulting potential root disturbance will stay off of the drip line zone of all three trees and thus cause the least amount of stress and instability to all plants.

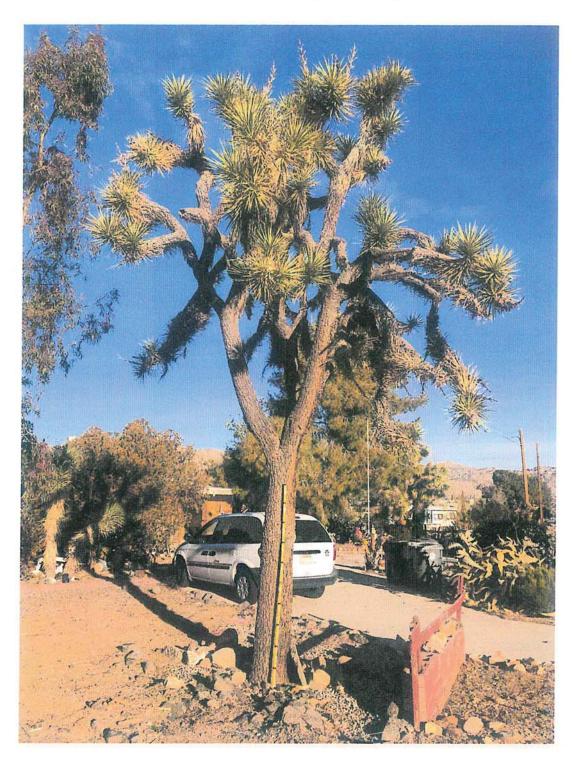
PLANT NUMBER: 1

STATUS (TRANSPLANT, DESTROY, PROTECT): PROTECT IN PLACE

CLASS SIZE: C (POLE = 2 meters)

DRIP LINE RADIUS: Approximately 9 ft

DISTANCE FROM WORK: 131 inches or 10.9 ft

NATIVE PLANT A	ASSESSMENT FORM			
CLIENT: Sean Molina	DATE: 10/1			
ADDRESS: 7516 Barberry Ave Yucca Valley, CA 92284				
PLANT #: 1	H: 480-550cm (16-18ft) W: 450-550cm (15-18ft)			
CLASS SIZE: C (greater than 4 m) STATUS: PRESERVED				
SITE FACTORS: Residential				
TOPOGRAPHY: Mostly flat	ASPECT: NE			
SOIL CONDITIONS: sandy				
PREVAILING WIND DIRECTION: SW	WIND EXPOSURE: High			
PAST SITE DISTURBANCES: Unknown	1			
HEALTH AND SPECIES PROFILE				
VIGOR (low/normal/high): Normal to low				
FOLIAGE: Short leaves, good color	CHLOROTIC: No			
PESTS: None visible, some woodpecker damage				
ABIOTIC FACTORS: None visible

# OF LIVE BRANCHES: 50-60 +/- arms; this is a very old	d plant			
LIVING CONDITION 0=dormant, 2=25% alive, 3=50% al				
# OF PUPS OR SAPLINGS generally up to 1 m is a pup; i				
CROWN DENSITY (sparse/normal/dense): Normal	DRIP LINE RADIUS: 270 (9 ft)			
DODDER/MISTLETOE/MOSS/LICHEN: None	John Entermission End (5 tt)			
SPECIES RISK POTENTIAL (branches/trunk/roots): mod	lerate risk for branch failure due to age			
CROWN AND BRANCHES	icrate risk for prantil randre due to age

# OF DEAD BRANCHES: 6	MAX BRANCH DIAMETER: 45 cm (1.5 ft)			
# OVER-EXTENDED WEAK ATTACHMENTS: None imme				
PREVIOUS BRANCH FAILURES: 1	salute, sat several poteritally weak			
FIRE OR LIGHTNING DAMAGE: None				
MISSING BARK/CAVITY/NEST/CRACKS: None on branch	hes			
FORMS OF DECAY (CONKS/MUSHROOMS/OOZE/GALL				
TRUNK	5). None			
MISSING BARK/CAVITY/NEST/CRACKS: Woodpecker ho	oles			
FORMS OF DECAY (CONKS/MUSHROOMS/OOZE/GALLS				
LEAN: Straight STAKING OR GUYING REC: Not at this time				
FOR DEAD TREES - ESTIMATED TIME SINCE DEATH: NA				
ROOTS				
	ION: Ok move rocks off the base of trunk			
COLLAR BURIED: No ROOT FLARE CONDITION: Ok, move rocks off the base of trunk DEAD/CAVITY/CRACKS: Not visible				
FORMS OF DECAY (CONKS/MUSHROOMS/OOZE/GALLS): None				
	FROM TRUNK: NA			
SOIL WEAKNESS: Not visible	TROW TRONK, NA			
CONSTRUCTION NOTES				
PUP SEPARATATION OR ROOT DIVIDING: Not recomme	ended			
RECOMMENDED BUIDABLE RADIUS: Stay off drip line v

RECOMMENDATION: Given plant size, overall age and adjacency to driveway and street, it is best to stay off this tree as much as possible. 131 inches stays off the drip line and should suffice to allow tree to recover.

plant, this is an old plant and is not in the best health a				
roots within the drip line radius, root system has the p				
ESTIMATED TRANSPLANT SURVIVAL RATE: Do not trans				
FREATMENT RECOMMENDATIONS: Do not cut roots la				
GIGNATURE: MARINNA WAGNER	DATE: 10/4/21			
Ma Man	DATE. 10/4/21

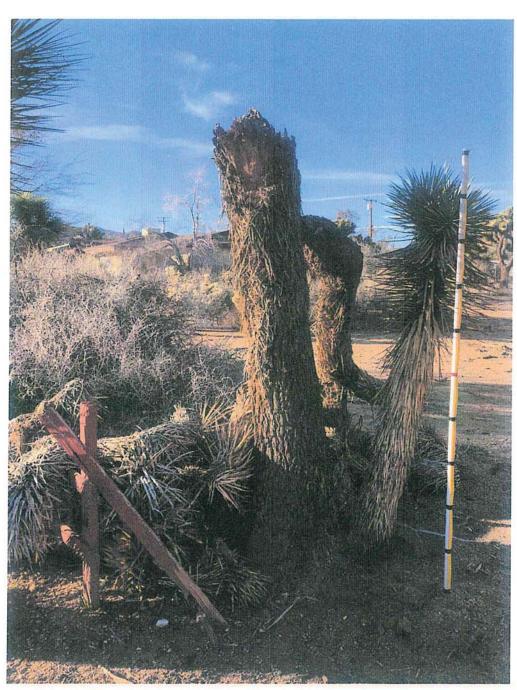
PLANT NUMBER: 2

STATUS (TRANSPLANT, DESTROY, PROTECT): PROTECT IN PLACE; TBD

CLASS SIZE: B (POLE = 2 meters)

DRIP LINE RADIUS: The drip line radius of the pup alone is only about 3 ft however, it likely relies on a portion

of th larger root system from the mother plant.

DISTANCE FROM WORK: 91 inches or 7.6 ft

View facing northeast

View facing southwest standing on street

NATIVE PLANT A	SSESSM	ENT FOR	M
CLIENT: Sean Molina		DATE: 10,	/1	
ADDRESS: 7516 Barberry Ave Yucca Valley, CA 92284		ASSESSOR(S): MW		
PLANT#: 2		H:274 cm		W: 182 cm (6 ft)
CLASS SIZE: B (1-4m)	STATUS: PRESERVED			
SITE FACTORS: Residential				Western Company of the Company of th
TOPOGRAPHY: Mostly flat		ASPECT: N	NE	
SOIL CONDITIONS: sandy		The second second second		
PREVAILING WIND DIRECTION	I: SW	WIND EXP	POSURE: Hi	gh
PAST SITE DISTURBANCES: Un	known	And the Arrest Actions	The state of the s	9
HEALTH AND SPECIES PROFIL	E			
VIGOR (low/normal/high): No	rmal, good			
FOLIAGE: Long leaves, good co			CHLOROT	IC: No
PESTS: None visible				
ABIOTIC FACTORS: Mother pla	ant is dead, unknown cau	ses, looks	like snappe	ed in the wind

# OF LIVE BRANCHES: 5 on pu				
LIVING CONDITION 0=dorman		ive, 4=75%	alive, 5=10	00% alive: 2
# OF PUPS OR SAPLINGS gene				
CROWN DENSITY (sparse/norm			RADIUS: 9	
DODDER/MISTLETOE/MOSS/L				
SPECIES RISK POTENTIAL (bran		currently		
CROWN AND BRANCHES				
OF DEAD BRANCHES: Many	arms dead 8-10 approx.	MAX BRA	NCH DIAME	TER: 76 cm (30 in)
OVER-EXTENDED WEAK ATT				
PREVIOUS BRANCH FAILURES:			likely due t	o weight and wind
FIRE OR LIGHTNING DAMAGE:				
MISSING BARK/CAVITY/NEST/	CRACKS: None			
FORMS OF DECAY (CONKS/MU		i): None		
TRUNK		,,,,,,,,,,,,,,,,,,,,,,,,,,,,,,,,,,,,,,,		
MISSING BARK/CAVITY/NEST/	CRACKS: None			
FORMS OF DECAY (CONKS/ML		i): None		Charles of the control of the contro
EAN: Slight	STAKING OR GUYING		at this time	9
FOR DEAD TREES - ESTIMATED				
ROOTS				
COLLAR BURIED: No	ROOT FLARE CONDITION	ON: Ok		and places and a second se
DEAD/CAVITY/CRACKS: None				
FORMS OF DECAY (CONKS/MU	JSHROOMS/OOZE/GALLS): None

RECOMMENDATION: Given vigor, health of pup, and that the majority of the root system to the south is undisturbed, it can likely survive some root damage and 7.6 ft should suffice. Dead branches on the ground can be removed if desired or they can be left on site, but it is not recommended to dig up the main trunk as that will disturb the live pup. Instead the main trunk could be cut back if desired for aesthetic reasons.

PREVIOUSLY CUT/DAMAGED R			NK: NA	
OIL WEAKNESS: Not visible				
CONSTRUCTION NOTES		·		96-11
UP SEPARATATION OR ROOT	DIVIDING: Not recomme	nded		
		- A - A - A - A - A - A - A - A - A - A	orox. 6-8' fr	om center of plant; it is likely
				th is good and thus recovery from
				e potential to be 10-12' wide.
STIMATED TRANSPLANT SUR				- paramata to be to the wine.
REATMENT RECOMMENDATION				eter
IGNATURE: MARINNA WAGNI		oci trian I	DATE: 10/4	
Ma Man	and the second s		JA11. 10/1	T] 60-36
1 000		T EXPERT

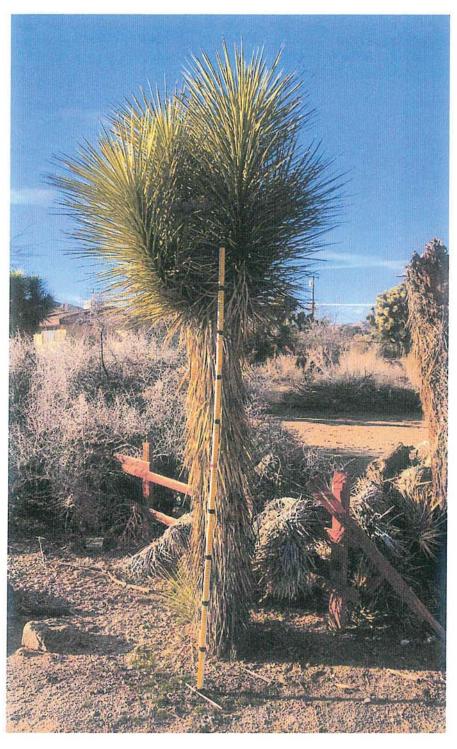
PLANT NUMBER: 3

STATUS (TRANSPLANT, DESTROY, PROTECT): PROTECT IN PLACE

CLASS SIZE: B (POLE = 2 meters)

DRIP LINE RADIUS: 6 ft

Red tape to end of pole is 1 meter. This plant is more than 1 meter away from plant #2 and thus considered an individual.

N	ATIVE PLANT ASSI	ESSMENT FORM			
CLIENT: Sean Molina		DATE: 10/1			
ADDRESS: 7516 Barberry Ave Yucca Valley, CA 92284		ASSESSOR(S): MW			
PLANT#: 3		H: 182 cm (6 ft) W: 182 cm (6 ft)			
CLASS SIZE: B (1-4m) STATUS: PRESERVED					
SITE FACTORS: Residential					
TOPOGRAPHY: Mostly flat		ASPECT: NE			
SOIL CONDITIONS: sandy					
PREVAILING WIND DIRECTION:	SW	WIND EXPOSURE: High			
PAST SITE DISTURBANCES: Unk		Trinib Ext Gootte, riigh			
HEALTH AND SPECIES PROFILE		AMBIECH ROBERT AND			
VIGOR (low/normal/high): Nor	mal. good				
FOLIAGE: Long leaves, good co		CHLOROTIC: No			
PESTS: None visible	01	onzonome. No			
ABIOTIC FACTORS: None	THE TAXABLE THE THE WORLDOOM

# OF LIVE BRANCHES: 5					
	2=25% alive 3=50% al	ive, 4=75% alive, 5=100% alive: 5			
		more than 1 m can be a separate individual: 1			
CROWN DENSITY (sparse/norm		DRIP LINE RADIUS: 91 cm (3 ft)			
DODDER/MISTLETOE/MOSS/LIG		DRIP LINE RADIOS: 91 CIT (5 It)			
SPECIES RISK POTENTIAL (brand		a company the			
CROWN AND BRANCHES	nes/trunk/roots): None	currently			
		IMAN DRANGU DIAMETER, 04 (22 :-)			
OVER EXTENDED WEAK ATTA	CUNATAITC Name -	MAX BRANCH DIAMETER: 81 cm (32 in)			
OVER-EXTENDED WEAK ATTA		ntiy			
PREVIOUS BRANCH FAILURES: I					
FIRE OR LIGHTNING DAMAGE:					
MISSING BARK/CAVITY/NEST/C		· ·			
FORMS OF DECAY (CONKS/MU:	SHROOMS/OOZE/GALLS	S): None			
TRUNK					
MISSING BARK/CAVITY/NEST/C					
FORMS OF DECAY (CONKS/MUS					
	EAN: Slight STAKING OR GUYING REC: None at this time				
OR DEAD TREES - ESTIMATED	TIME SINCE DEATH: NA				
ROOTS					
COLLAR BURIED: No	ROOT FLARE CONDITI	ON: Ok			
DEAD/CAVITY/CRACKS: None

RECOMMENDATION: Best to leave in place, this is a healthy plant

ORMS OF DECAY (CONKS/MUS		s): None			
PREVIOUSLY CUT/DAMAGED RO	DOTS: NA DISTANCE	FROM TRUNK: NA			
SOIL WEAKNESS: Not visible					
CONSTRUCTION NOTES					
PUP SEPARATATION OR ROOT [
RECOMMENDED BUIDABLE RAD	DIUS: Stay off drip line, I	best to maintain radius of 6-8' from plant,			
oot system has the potential to	be 10-12' wide				
STIMATED TRANSPLANT SURV	VAL BATE: Not necessar	PN			
REATMENT RECOMMENDATION					
GIGNATURE: MARINNA WAGNE	N	DATE: 10/4/21			
HAVE 133EAA ISA CERTIEIED AR	DODICT & MATRIC DI AAS	T EVDERT

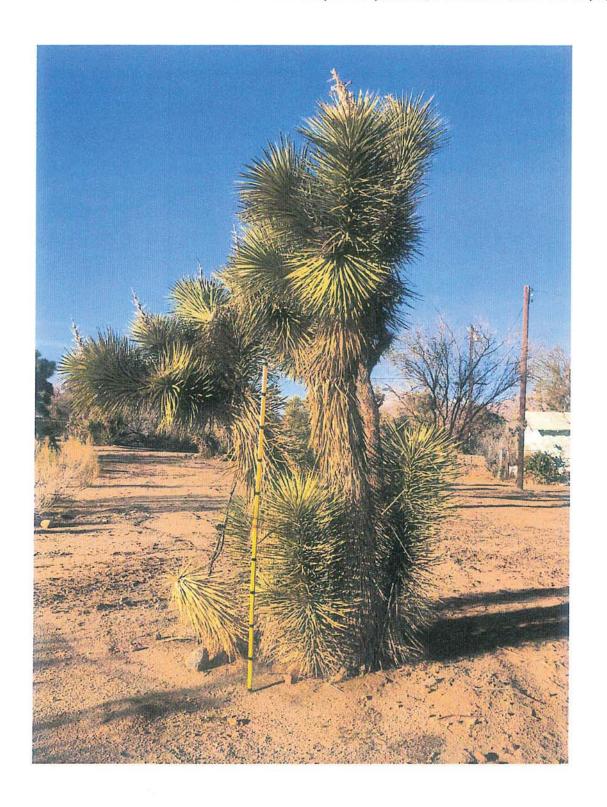
PLANT NUMBER: 4

STATUS (TRANSPLANT, DESTROY, PROTECT): PROTECT IN PLACE

CLASS SIZE: B (POLE = 2 meters)
DISTANCE FROM WORK: 10 ft

NATIVE	PLANT A	SSESSM	ENT FOR	M
CLIENT: Sean Molina		DATE: 10/1		
ADDRESS: 7516 Barberry Ave Yucca Valley, CA 92284		ASSESSOR		
		H: 340 cm		W: 305 cm (10 ft)
No contract and contract of the	RESERVED I			
SITE FACTORS: Residential				
TOPOGRAPHY: Mostly flat		ASPECT: N	IE	
SOIL CONDITIONS: sandy				
PREVAILING WIND DIRECTION: SW		WIND EXP	OSURE: Hig	rh
PAST SITE DISTURBANCES: Unknown				
HEALTH AND SPECIES PROFILE				
VIGOR (low/normal/high): Normal, great				**************************************
FOLIAGE: Long leaves, good color			CHLOROTI	C: No
PESTS: No visible				
ABIOTIC FACTORS: None visible

# OF LIVE BRANCHES: 16				account of the second of the s
LIVING CONDITION 0=dormant, 2=25% alive	, 3=50% ali	ve, 4=75%	alive, 5=10	0% alive: 5
# OF PUPS OR SAPLINGS generally up to 1 m				
CROWN DENSITY (sparse/normal/dense): De			RADIUS: 18	
DODDER/MISTLETOE/MOSS/LICHEN: None				
SPECIES RISK POTENTIAL (branches/trunk/ro	oots): None			
CROWN AND BRANCHES

# OF DEAD BRANCHES: 0	1	MAX BRAN	NCH DIAME	TER: 60 cm (24 in)
# OVER-EXTENDED WEAK ATTACHMENTS: N				
PREVIOUS BRANCH FAILURES: None				1119 (14-14) (14-14) (14-14) (14-14)
FIRE OR LIGHTNING DAMAGE: None				
MISSING BARK/CAVITY/NEST/CRACKS: None	2			
FORMS OF DECAY (CONKS/MUSHROOMS/O): None		
TRUNK		,		
MISSING BARK/CAVITY/NEST/CRACKS: None	2			**************************************
FORMS OF DECAY (CONKS/MUSHROOMS/O): None		
LEAN: Slight south STAKING O	0.00			
FOR DEAD TREES - ESTIMATED TIME SINCE I	THE RESERVE OF THE PARTY OF THE			
ROOTS				
	RE CONDITIO	ON: Ok		STEENING BUILDING STEENINGS STEENINGS
DEAD/CAVITY/CRACKS: None				
FORMS OF DECAY (CONKS/MUSHROOMS/O	OZE/GALLS): None		
	DISTANCE F		NK: NA	
SOIL WEAKNESS: Not apparent				
CONSTRUCTION NOTES				
PUP SEPARATATION OR ROOT DIVIDING: No	t recomme	nded	************	
RECOMMENDED BUIDABLE RADIUS: Stay of			to stay app	rox. 8' away from plant.
Since this plant is in very good health, the ch

RECOMMENDATION: Best to leave in place. Tree is healthy and will likely recover some minor root

disturbance. Given the size of the tree transplant is possible, but with the number of pups it will be difficult.

ESTIMATED TRANSPLANT SURVIVAL RATE: T				0 - 10 mg
TREATMENT RECOMMENDATIONS: Do not o				ter
SIGNATURE: MARINNA WAGNER		oc. man 1	DATE: 10/4	
Ma Mora			271121 10/4	,

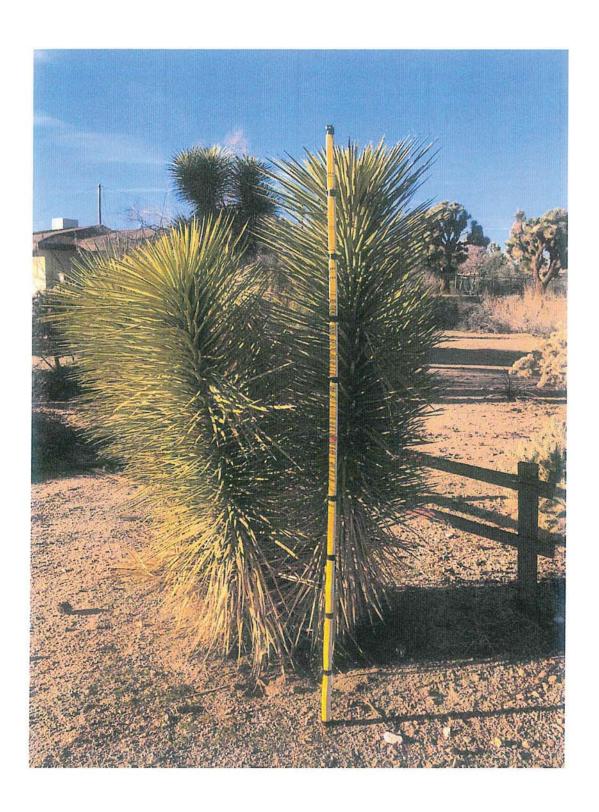
PLANT NUMBER: 5

STATUS (TRANSPLANT, DESTROY, PROTECT): PROTECT IN PLACE

CLASS SIZE: B (POLE = 2 meters) DISTANCE FROM WORK: 35 ft

NATIVE PLA	NT ASSESSMENT FORM			
CLIENT: Sean Molina	DATE: 10/1			
ADDRESS: 7516 Barberry Ave Yucca Valley, CA				
PLANT #: 5	H: 180 cm (6 ft) W: 180 cm (6 ft)			
	ERVED IN PLACE			
SITE FACTORS: Residential				
TOPOGRAPHY: Mostly flat	ASPECT: NE			
SOIL CONDITIONS: sandy	7.07.2011112			
PREVAILING WIND DIRECTION: SW	WIND EXPOSURE: High			
PAST SITE DISTURBANCES: Unknown	THE EN COUNTY INDI			
HEALTH AND SPECIES PROFILE				
VIGOR (low/normal/high): Normal				
FOLIAGE: Long leaves, good color	CHLOROTIC: No			
PESTS: None	CHEONOTIC. NO			
ABIOTIC FACTORS: None

# OF LIVE BRANCHES: 5				
LIVING CONDITION 0=dormant, 2=25% alive, 3=	50% alive 4=75% alive 5=100% alive: 5			
	a pup; more than 1 m can be a separate individual: all pups?			
CROWN DENSITY (sparse/normal/dense): Norm				
DODDER/MISTLETOE/MOSS/LICHEN: None	Idi Dili Elile NADIOS. 32 dili (3 ti)			
SPECIES RISK POTENTIAL (branches/trunk/roots	e): None			
CROWN AND BRANCHES). None

# OF DEAD BRANCHES: 1	MAX BRANCH DIAMETER: 50 cm (20")			
# OVER-EXTENDED WEAK ATTACHMENTS: None				
PREVIOUS BRANCH FAILURES: None				
FIRE OR LIGHTNING DAMAGE: None				
MISSING BARK/CAVITY/NEST/CRACKS: None				
FORMS OF DECAY (CONKS/MUSHROOMS/OOZI	E/GALLS): None			
TRUNK	-/ GALLS/. Notice			
MISSING BARK/CAVITY/NEST/CRACKS: None				
FORMS OF DECAY (CONKS/MUSHROOMS/OOZI	E/GALLS): None			
	UYING REC: None			
FOR DEAD TREES - ESTIMATED TIME SINCE DEA	Charles of the Contract of the			
ROOTS	TH. NA			
	ONDITION: OK			
DEAD/CAVITY/CRACKS: None	ONDITION. OK			
FORMS OF DECAY (CONKS/MUSHROOMS/OOZE	E/GALLS): None			
	TANCE FROM TRUNK: NA			
SOIL WEAKNESS: Not visible	TANCE FROM TRONK. NA			
CONSTRUCTION NOTES				
PUP SEPARATATION OR ROOT DIVIDING: Not re	commended			
	tree by at least 6-8 ft; work is approximately 40 ft from tree			
ESTIMATED TRANSPLANT SURVIVAL RATE: Tran				
TREATMENT RECOMMENDATIONS: Do not cut r

RECOMMENDATION: Best to leave in place, this is a healthy plant.

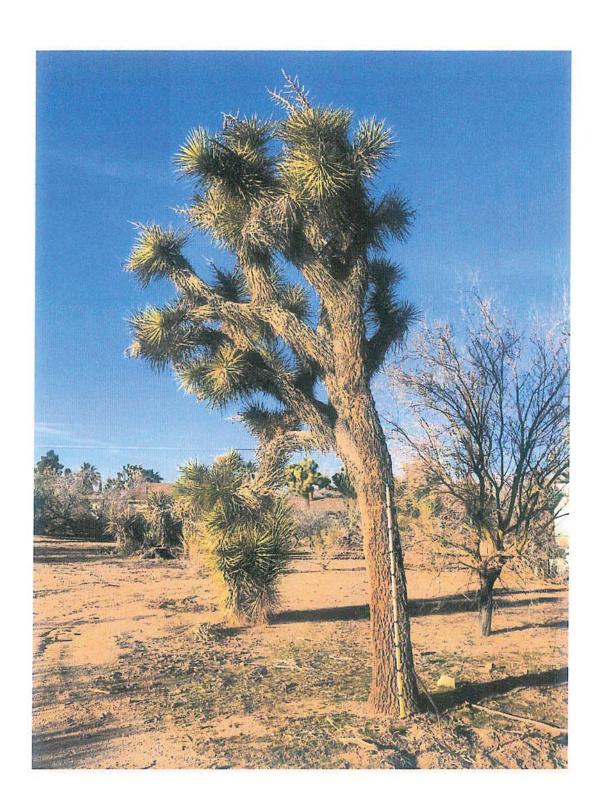
PLANT NUMBER: 6

STATUS (TRANSPLANT, DESTROY, PROTECT): PROTECT IN PLACE

CLASS SIZE: C (POLE = 2 meters)
DISTANCE FROM WORK: 20 ft

NATIVE PLANT A	SSESSMENT FORM			
CLIENT: Sean Molina	DATE: 1/4/22			
ADDRESS: 7516 Barberry Ave Yucca Valley, CA 92284	ASSESSOR(S): MW			
PLANT #: 6	H: 5 m (16 ft) W: 3.2 m (10.5 ft)			
CLASS SIZE: C (4+ m) STATUS: PRESERVED				
SITE FACTORS: Residential				
TOPOGRAPHY: Mostly flat	ASPECT: NE			
SOIL CONDITIONS: Sandy	7/8/12011/12			
PREVAILING WIND DIRECTION: SW	WIND EXPOSURE: High			
PAST SITE DISTURBANCES: Unknown	TVIND EXI GOOKETING!			
HEALTH AND SPECIES PROFILE				
VIGOR (low/normal/high): Normal				
FOLIAGE: Good color, normal	CHLOROTIC: No			
PESTS: None	CHECKOTIC. NO			
ABIOTIC FACTORS: None

# OF LIVE BRANCHES: 40 +/-				
LIVING CONDITION 0=dormant, 2=25% alive, 3=50% al	live 4=75% alive 5=100% alive: 5			
# OF PUPS OR SAPLINGS generally up to 1 m is a pup;				
CROWN DENSITY (sparse/normal/dense): Normal	DRIP LINE RADIUS: 4.5 m (15 ft)			
DODDER/MISTLETOE/MOSS/LICHEN: None	DRIF LINE NADIOS. 4.5 III (15 IL)			
SPECIES RISK POTENTIAL (branches/trunk/roots): None				
CROWN AND BRANCHES				
	IMAY BRANCH DIAMETER: 60 cm (1.0 ft)

# OF DEAD BRANCHES: 3 MAX BRANCH DIAMETER: 60 cm (1.9 ft)				
# OVER-EXTENDED WEAK ATTACHMENTS: None PREVIOUS BRANCH FAILURES: None				
FIRE OR LIGHTNING DAMAGE: None				
MISSING BARK/CAVITY/NEST/CRACKS: None				
FORMS OF DECAY (CONKS/MUSHROOMS/OOZE/GALL:	C). None			
TRUNK	s). Notie			
ALCOHOLOGY TO THE PROPERTY OF				
MISSING BARK/CAVITY/NEST/CRACKS: None	C). No. 10			
FORMS OF DECAY (CONKS/MUSHROOMS/OOZE/GALL				
LEAN: South STAKING OR GUYING				
FOR DEAD TREES - ESTIMATED TIME SINCE DEATH: NA				
ROOTS	ou or i i i i i			
	ON: OK, some site erosion around the base			
DEAD/CAVITY/CRACKS: None	2) Al			
FORMS OF DECAY (CONKS/MUSHROOMS/OOZE/GALLS				
	FROM TRUNK: NA			
SOIL WEAKNESS: Not visible				
CONSTRUCTION NOTES				
PUP SEPARATATION OR ROOT DIVIDING: Not recomme				
	at least 15 ft especially to the south where wide roots are			
ESTIMATED TRANSPLANT SURVIVAL RATE: Transplant i				
TREATMENT RECOMMENDATIONS: Do not cut roots la

RECOMMENDATION: Best to leave in place, this is a healthy plant and is contributing to the seed bank.

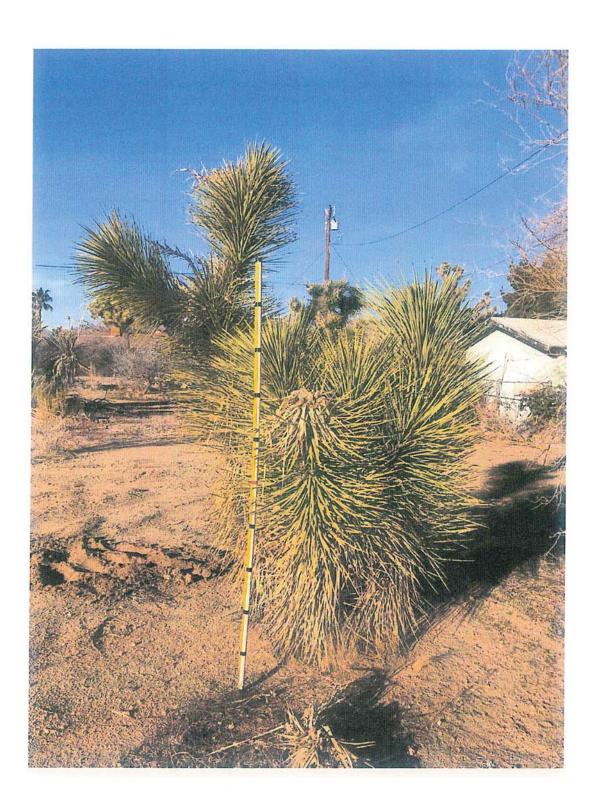
PLANT NUMBER: 7

STATUS (TRANSPLANT, DESTROY, PROTECT): PROTECT IN PLACE

CLASS SIZE: B (POLE = 2 meters)
DISTANCE FROM WORK: 25 ft

NATIVE PLANT	ASSESSMENT FORM				
CLIENT: Sean Molina	DATE: 1/4/22				
ADDRESS: 7516 Barberry Ave Yucca Valley, CA 92284					
PLANT #: 7	H: 2.4 m (7.8 ft) W: 2.4 m (7.8 ft)				
CLASS SIZE: B (1-4 m) STATUS: PRESERVED					
SITE FACTORS: Residential					
TOPOGRAPHY: Mostly flat	ASPECT: NE				
SOIL CONDITIONS: Sandy					
PREVAILING WIND DIRECTION: SW WIND EXPOSURE: High					
PAST SITE DISTURBANCES: Unknown	11				
HEALTH AND SPECIES PROFILE					
VIGOR (low/normal/high): Normal	THE RESIDENCE OF THE PROPERTY				
FOLIAGE: Good color, very long leaves	CHLOROTIC: No				
PESTS: None					
ABIOTIC FACTORS: None

# OF LIVE BRANCHES: 11					
LIVING CONDITION 0=dormant, 2=25% alive, 3=50% a	alive, 4=75% alive, 5=100% alive: 5				
# OF PUPS OR SAPLINGS generally up to 1 m is a pup;					
CROWN DENSITY (sparse/normal/dense): Normal	DRIP LINE RADIUS: 1.8 m (6 ft)				
DODDER/MISTLETOE/MOSS/LICHEN: None	the state of the s				
SPECIES RISK POTENTIAL (branches/trunk/roots): Nor	ne				
CROWN AND BRANCHES

# OF DEAD BRANCHES: 1	MAX BRANCH DIAMETER: 80 cm (2.6 ft)				
# OVER-EXTENDED WEAK ATTACHMENTS: None					
PREVIOUS BRANCH FAILURES: None					
FIRE OR LIGHTNING DAMAGE: None					
MISSING BARK/CAVITY/NEST/CRACKS: None					
FORMS OF DECAY (CONKS/MUSHROOMS/OOZE/GAL	LS): None				
TRUNK					
MISSING BARK/CAVITY/NEST/CRACKS: None					
FORMS OF DECAY (CONKS/MUSHROOMS/OOZE/GAL	LS): None				
LEAN: South STAKING OR GUYING REC: None					
FOR DEAD TREES - ESTIMATED TIME SINCE DEATH: NA					
ROOTS					
COLLAR BURIED: No ROOT FLARE CONDIT	TION: OK				
DEAD/CAVITY/CRACKS: None					
FORMS OF DECAY (CONKS/MUSHROOMS/OOZE/GALI	LS): None				
PREVIOUSLY CUT/DAMAGED ROOTS: NA DISTANCE FROM TRUNK: NA					
SOIL WEAKNESS: Not visible					
CONSTRUCTION NOTES					
PUP SEPARATATION OR ROOT DIVIDING: Not recomm	nended				
RECOMMENDED BUIDABLE RADIUS: Stay off of tree b					
ESTIMATED TRANSPLANT SURVIVAL RATE: Transplant					
TREATMENT RECOMMENDATIONS: Do not cut roots I	arger than 1.5 inches diameter

RECOMMENDATION: Best to leave in place, this is a healthy plant and is contributing to the seed bank.
