Town of Yucca Valley
PLANNING COMMISSION STAFF REPORT

Subject: Western Joshua Tree (WJT) Permit 037-22, Onaga Trail (Acoma Trail to Palm Avenue), Yucca Valley CA.; Transplant One (1) Western Joshua Tree, Remove One (1) Dead Western Joshua Tree

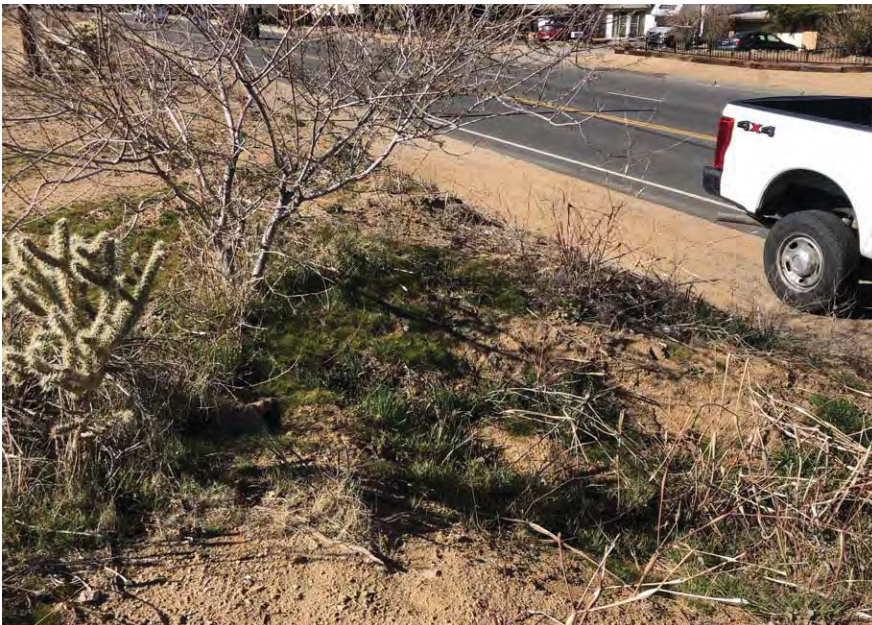
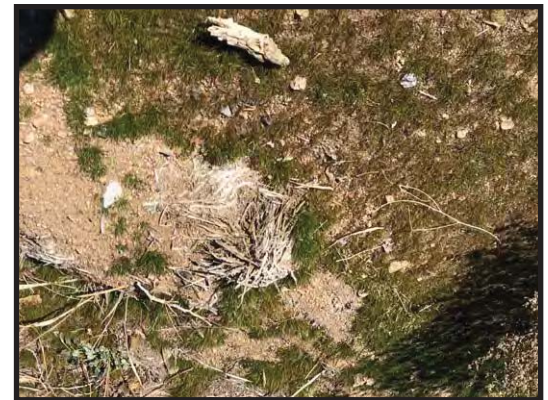
Images: Jan 2022

OTHER NOTES & RECOMMENDATIONS: On the plans there is a Joshua Tree identified at APN 0587-011-06 adjacent to a power pole and across the street from APN 0587-342-12. Given the location on the plans, this is our best guess as to where there might have been a tree. There is a significant hole next to the *Senegalia greggii* and *Cylindropuntia echinocarpa*. There is no tree present to date. There is some Joshua Tree branches and thatch on the ground behind the shrub, but due to the decay it doesn't appear to be recent damage. In Google Earth imagery from 2019 shows what appears to be a Joshua Tree. Activity and cause of death is unknown.

Left: Hole

Above: Some old Joshua Tree branches and thatch on the ground, they do not appear to be of recent death.

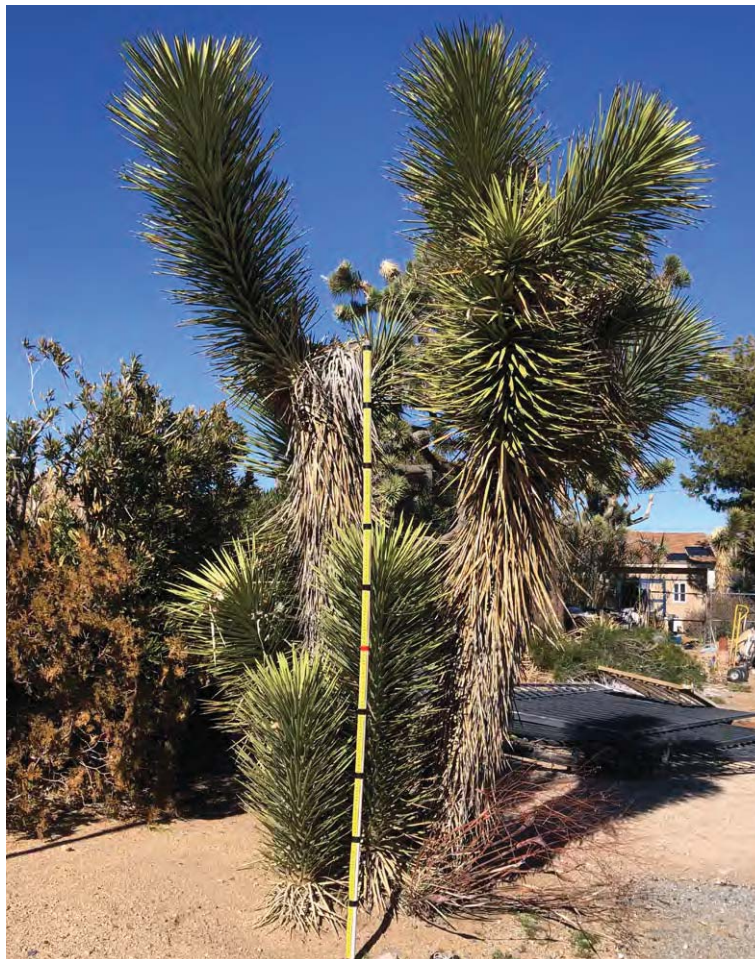
PLANT NUMBER: 3

DECAY OR DAMAGE: None currently, leaves show some signs of sunburn, but it is slight.

ROOT FLARE CONDITION: Ok, but slightly buried likely due to natural erosion.

TRANSPLANT FEASIBILITY NOTES: If possible to modify work to leave in place that would be ideal. If necessary this small tree could be transplanted away from the driveway apron and street curb.

OTHER NOTES & RECOMMENDATIONS: We are considering this a separate plant because it is more than 1 meter away from the main trunk, however it is not impossible that it is connected to the larger plant. If is connected, it may struggle to survive transplant, especially if it was depending on the larger root system, but this is unknown based on visual observation. Given size it is also recommended to cage the small plant to protect it from herbivores if relocated.

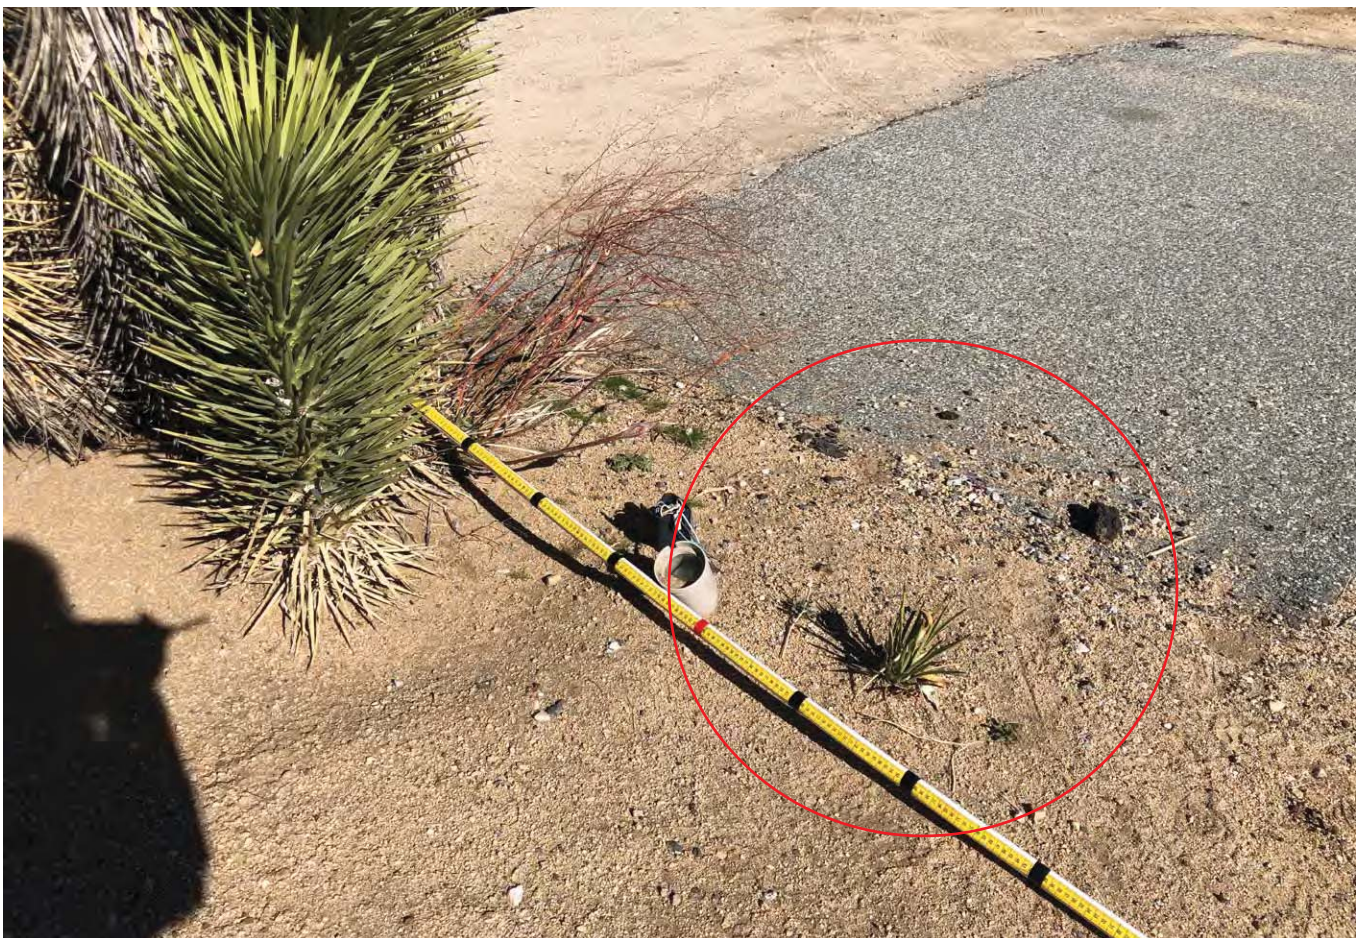
PLANT NUMBER: 4

DECAY OR DAMAGE: Nothing significant

ROOT FLARE CONDITION: Mounded up. Given mound it is best not to excavate significantly here.

TRANSPLANT FEASIBILITY NOTES: This plant is too large and complicated to transplant. Based on the site visit with the Inspector, it seems like work can stay off this tree by 10 ft from the center. It is recommended that the design be modified to stay off of the tree by at least 8 ft especially if the depth of the cut is more than 1 ft.

OTHER NOTES & RECOMMENDATIONS: Several of these pups are further than 1 meter from the main trunk, and could be considered separate plants, however given how the pups are arranged radially it is more likely they are all connected. It is possible that a pup may need to be trimmed back for public safety. Please consult and expert in tree pruning.

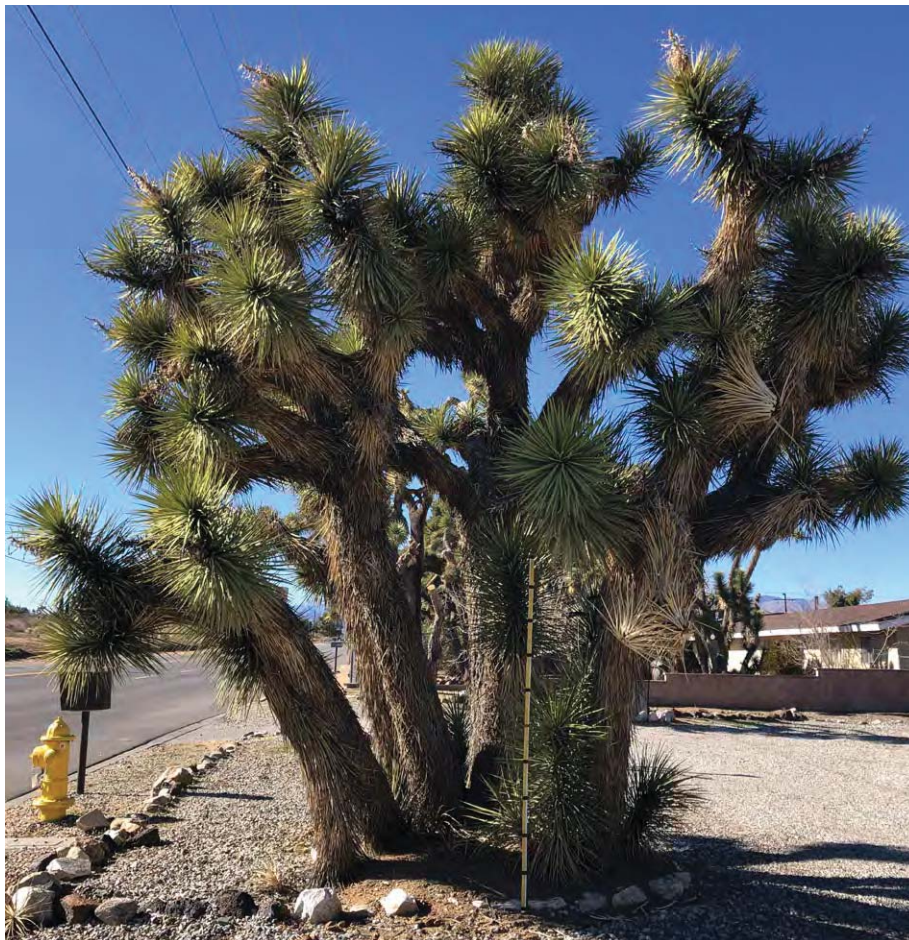
PLANT NUMBER: 5

MAJOR BRANCH FAILURES: 1

HEALTH CONDITION (0=dormant, 1= dead, 2=25% alive, 3=50% alive, 4=75% alive, 5=100% alive): 4

DECAY OR DAMAGE: Significant trunk damage at the base, likely mechanical and not recent.

TRANSPLANT FEASIBILITY NOTES: This tree is likely too large to move. It would be best to leave in place and work around it.

OTHER NOTES & RECOMMENDATIONS: Although the Town requires that work be 10 ft away from the center of the tree, based on the site visit with the Inspector, it appears work may occur close to 9 ft from the plant. Depending on the depth of work it is preferred to conduct grading within the dripline over attempting transplant of this tree. The tree can likely survive if minimal grading occurs adjacent to it and it has significantly less of a chance of surviving transplant to a new location given health and damages.

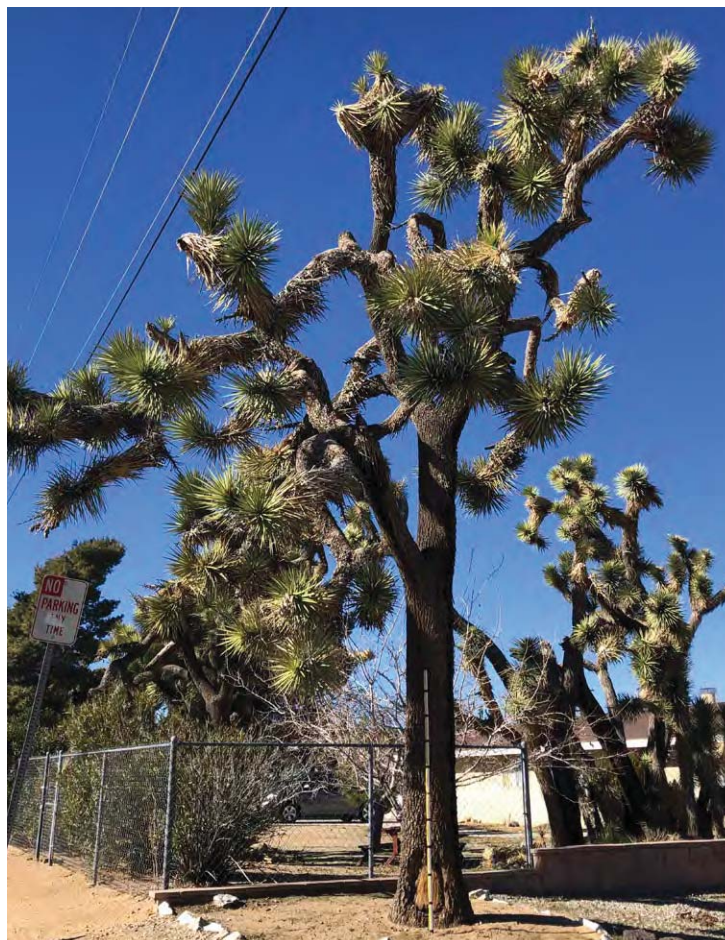
PLANT NUMBER: 6

DECAY OR DAMAGE: None

TRANSPLANT FEASIBILITY NOTES: Although feasible, it would be best to leave the tree in place and work around it.

OTHER NOTES & RECOMMENDATIONS: The Town requires that work be 10 ft away from the center of the tree, based on the site visit with the Inspector, it appears that the edge of the sidewalk is approximately 2 meters (approx. 6.5 ft) from the edge of the drip line of this tree and the cut appears to be less than 12 inches. This distance should be plenty of space to work around the tree. The tree can likely survive if minimal grading occurs adjacent to it.

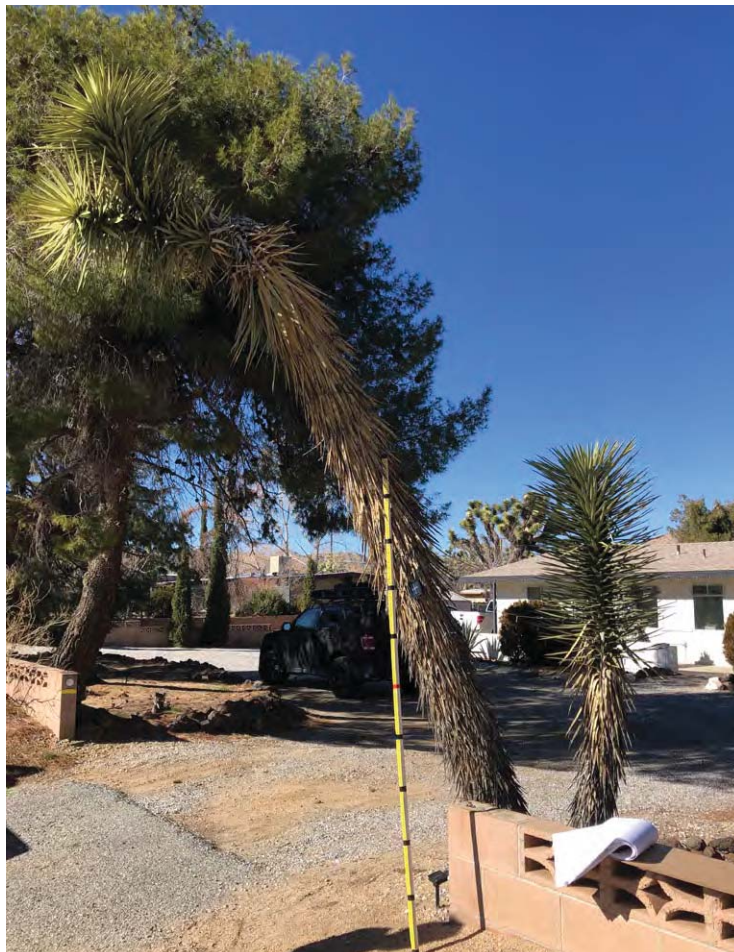
PLANT NUMBER: 7

DECAY OR DAMAGE: Some thatch loss due to age

TRANSPLANT FEASIBILITY NOTES: Not recommended due to the size. This tree may be difficult to frame and keep branches from snapping while moving. Also the digging necessary to transplant this tree will likely cause damage to the root system of the adjacent tree #8.

OTHER NOTES & RECOMMENDATIONS: Although the Town requires that work be 10 ft away from the center of the tree, based on the site visit with the Inspector, it appears work may occur close to 9 ft from the plant. The depth of work appears to minimal and only a few inches and thus is preferred to conduct grading within the dripline over attempting transplant of this tree. The tree can likely survive if minimal grading occurs adjacent to it and it has less of a chance of surviving transplant to a new location. This plant flowered recently and is contributing to the seed bank.

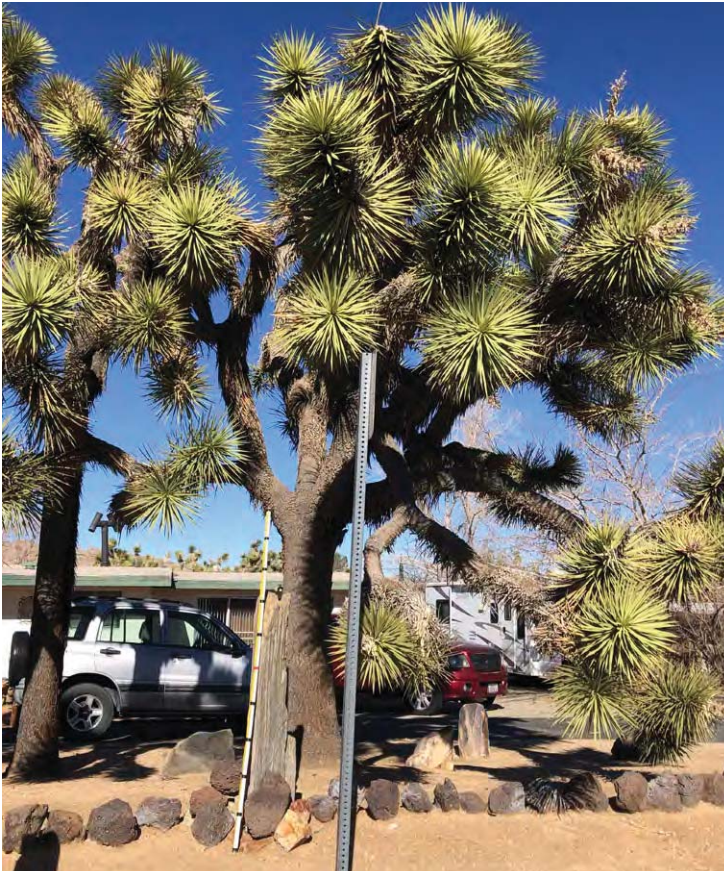
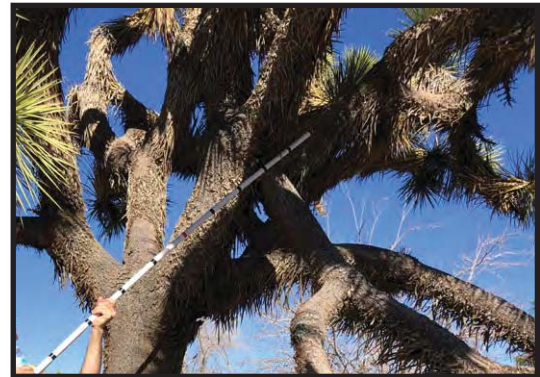
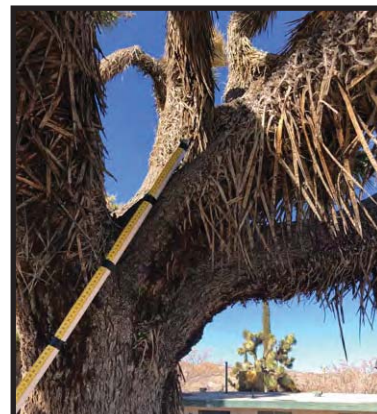
Tree may require pruning at these two joints for public safety to be determined in the field.

TRANSPLANT FEASIBILITY NOTES: Feasible, although not recommended. This tree may be difficult to frame and keep branches from snapping while moving. Also the digging necessary to transplant this tree will likely cause damage to the root system of the adjacent tree #7 and the two trees behind it.

OTHER NOTES & RECOMMENDATIONS: Although the Town requires that work be 10 ft away from the center of the tree, based on the site visit with the Inspector, it appears work may occur close to 7 ft from the plant. Since the drip line extends approximately 6.5 ft and the depth of work may only be a few inches, it is preferred to conduct grading within 7 ft of the plant over attempting transplant of this tree. The tree can likely survive if minimal grading occurs adjacent to it and it has less of a chance of surviving transplant to a new location. This plant flowered recently and is contributing to the seed bank.

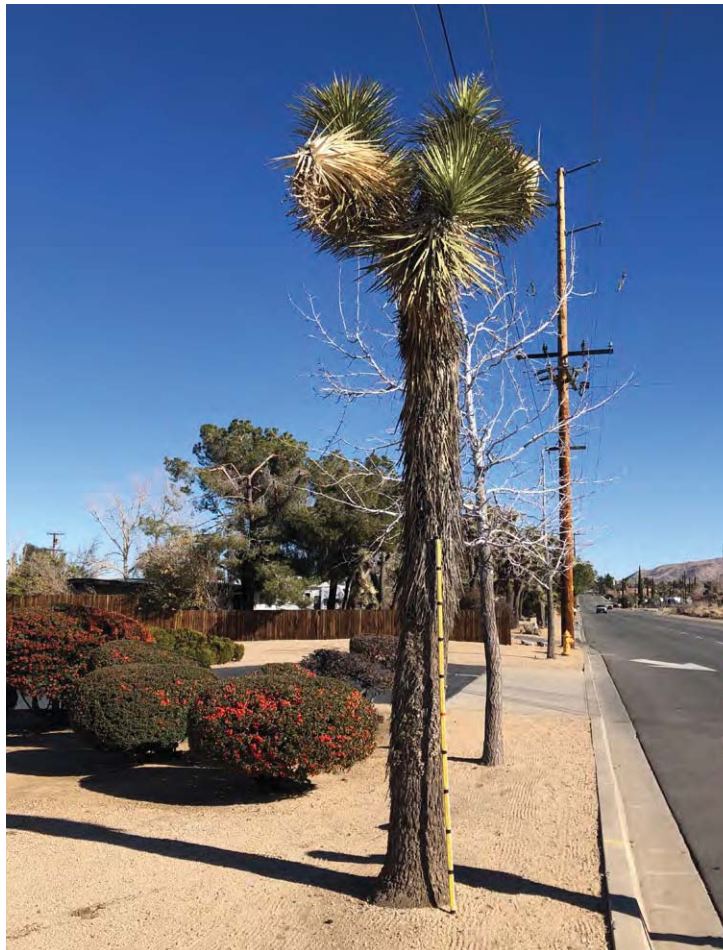
PLANT NUMBER: 10

HEALTH CONDITION (0=dormant, 1= dead, 2=25% alive, 3=50% alive, 4=75% alive, 5=100% alive): 1.5

DECAY OR DAMAGE: Mechanical damage at base.

ROOT FLARE CONDITION: Poor condition and buried. There is a mechanical cut at the base of the tree likely from some form of tool.

OTHER NOTES & RECOMMENDATIONS: This tree is on it's way out and will most likely not survive another year.

The likely cause of death is the large cut at the base and the buried root flare, but it is unknown at this stage the true cause of decline. The tree is unstable and moves significantly when touched. Given curb and road work, it is unknown if previous ground work cut roots on the south side.

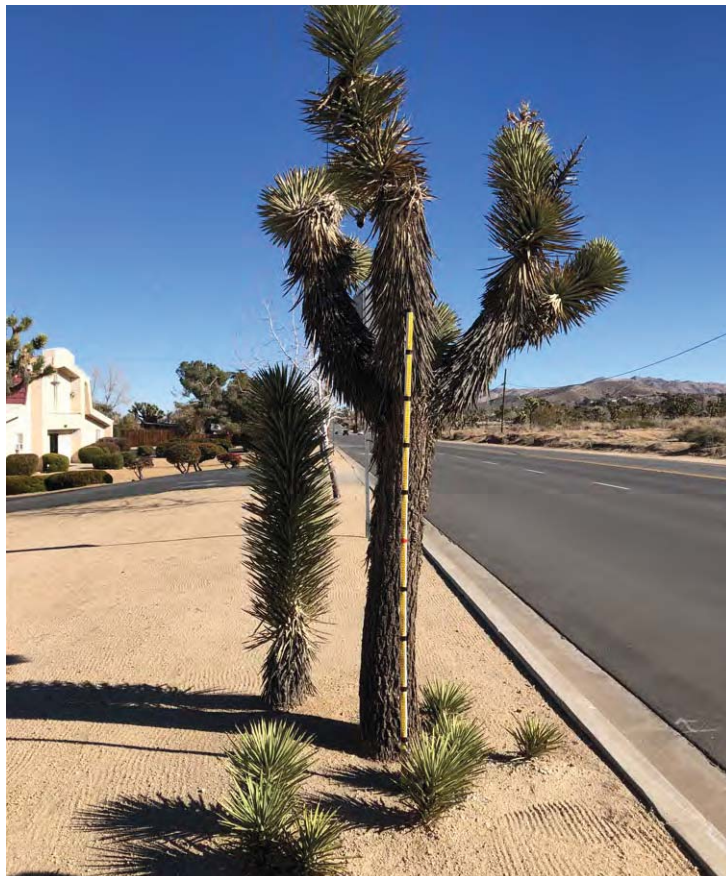
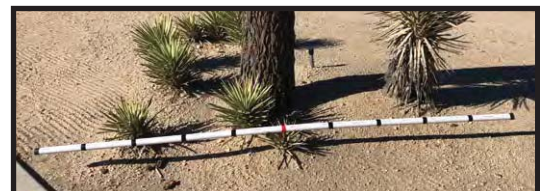
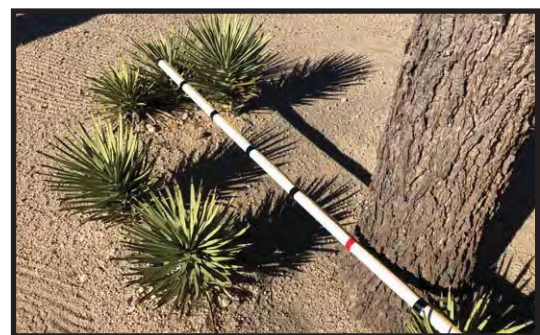
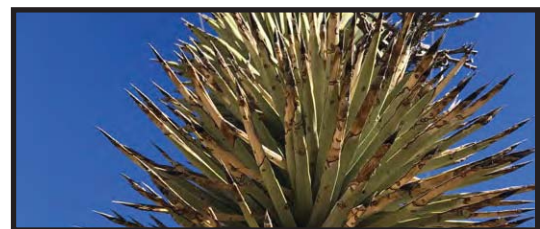
Images 1 &2: All pups within 1 meter of the main trunk

Image 3: Some damage to tips of leaves

TRANSPLANT FEASIBILITY NOTES: Possible, but this tree is very tall, has quite a few pups, and it's proximity to the power pole may create a significant challenge for excavation and transplant. Given curb and road work, it is unknown if previous ground work cut roots on the south side.

OTHER NOTES & RECOMMENDATIONS: Within the ROW it may be difficult to modify work and maintain 10 ft of distance from the tree. Grading appears to be only a few inches and if work can stay off the drip line radius, it is recommended to leave the plant in place as it is likely to survive minimal damage to a portion of the root system. Joshua Trees in general do not transplant well and whenever it is possible to modify work, the survival of the tree long-term will be higher than transplanting it to a new location. Please consult with contractors to determine if this tree is possible to transplant with equipment given size and power lines.

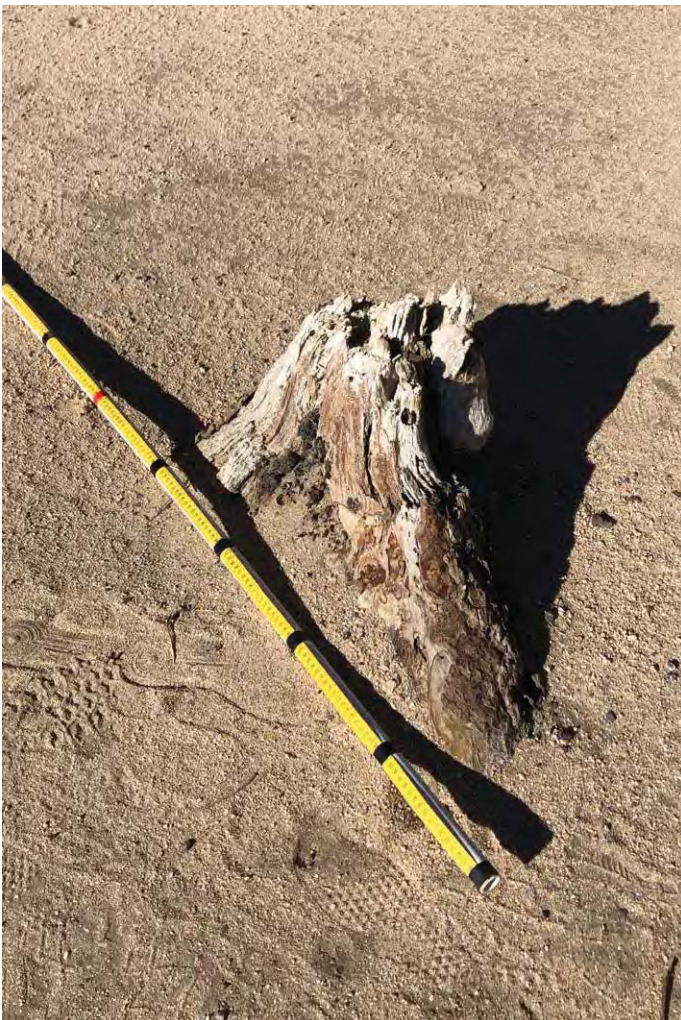
HEALTH CONDITION (0=dormant, 1= dead, 2=25% alive, 3=50% alive, 4=75% alive, 5=100% alive): 1

DECAY OR DAMAGE: Dead and decayed

OTHER NOTES & RECOMMENDATIONS: This trunk appears to be a dead Joshua Tree based on the appearance of the fibers and the exterior woodiness. Time and cause of death was not recent as the trunk is quite decayed and remaining plant material no longer exists on site.

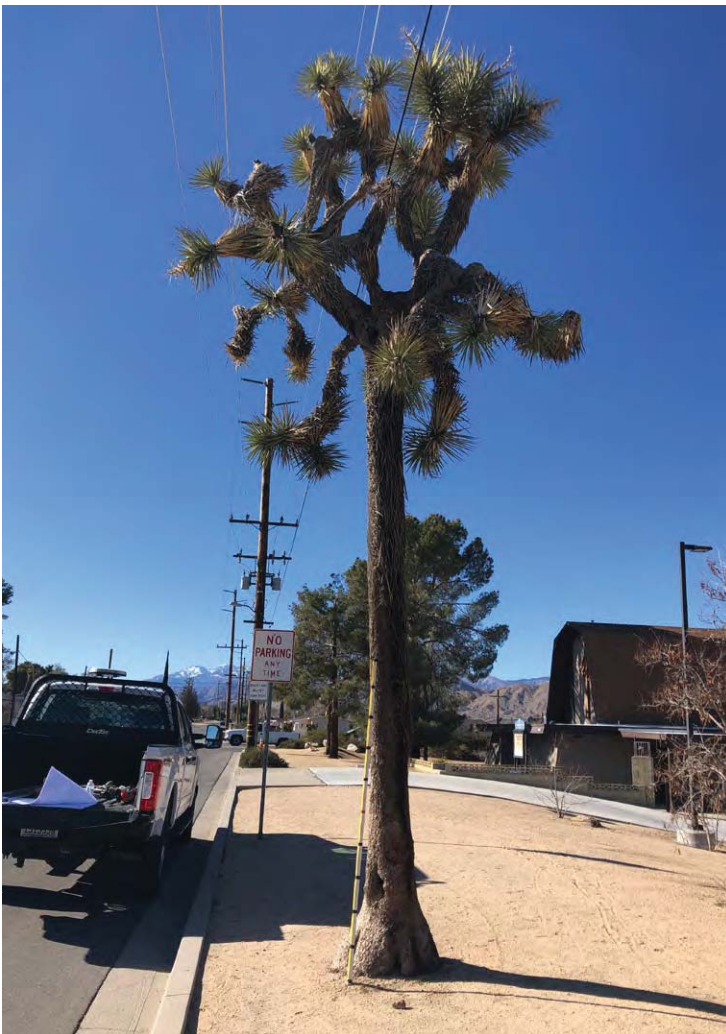
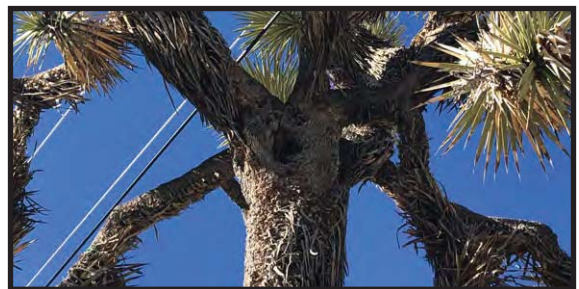
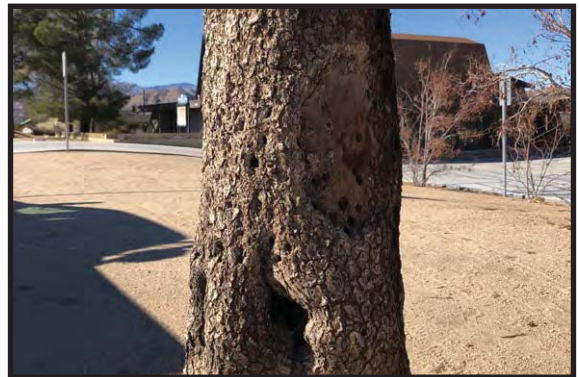
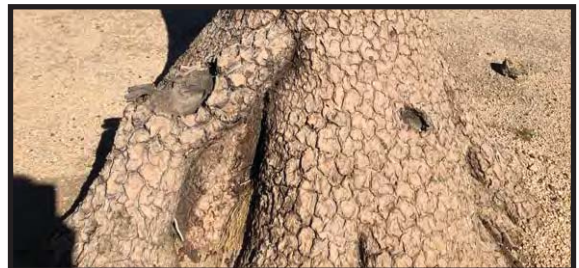
Image 1: Holes at large branch joint

Image 2: Woodpecker damage and holes near base
