Town of Yucca Valley PLANNING COMMISSION STAFF REPORT

Subject: Western Joshua Tree (WJT) Permit 038-22, Little League Drive (Palm Avenue to

Sage Avenue), Yucca Valley CA.; Transplant One (1) Western Joshua Tree,

NATIVE PLANT INVENTORY REPORT SITE MAP WITH PHOTOGRAPHIC CENSUS

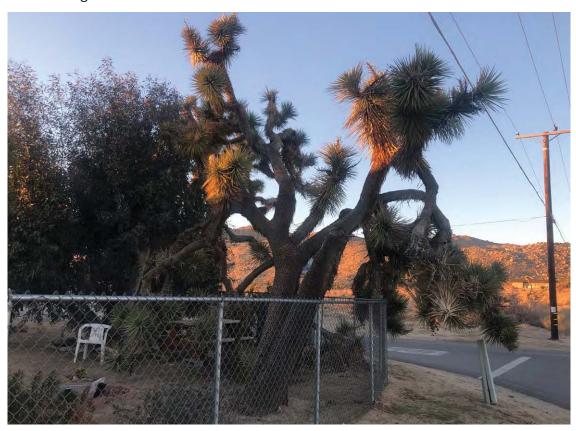
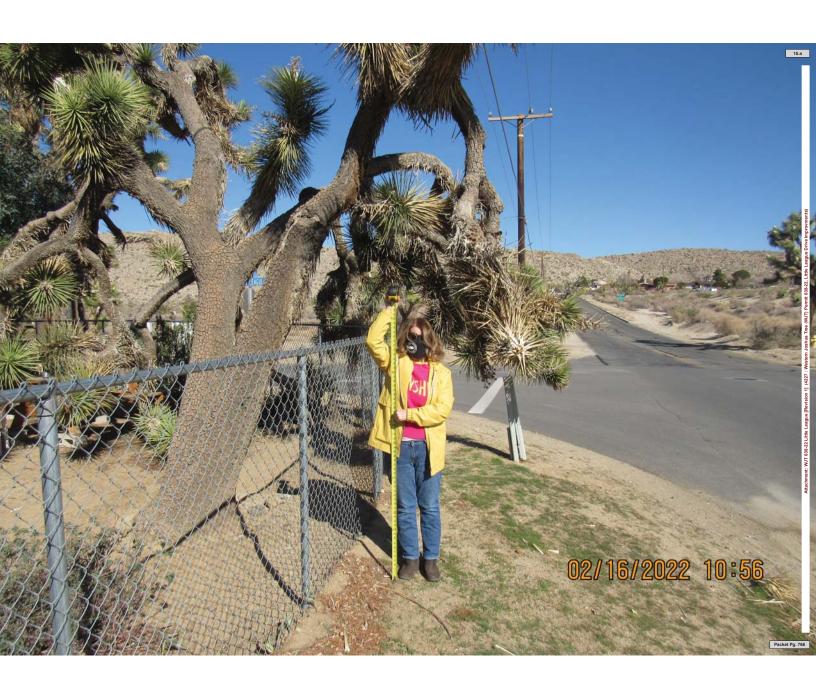
PLANT NUMBER: 1

STATUS (TRANSPLANT, DESTROY, PROTECT): Protect *outside of ROW on private property

LEAN: N VIGOR: High FOLIAGE: Good condition CROWN DENSITY: Dense

NUMBER OF DEAD BRANCHES: 7 MAJOR BRANCH FAILURES: 3

DECAY OR DAMAGE: Some thatch missing on branches and some woodpecker damage.

TRANSPLANT FEASIBILITY NOTES: It is not recommended to remove this tree. This is tree is a very old and large specimen and it is likely not possible to transplant successfully. It is recommended to modify the design to leave this plant in place especially since it is fully on private property. In addition, given the size of the pup, it will be a challenge to transplant them together.

OTHER NOTES & RECOMMENDATIONS: Several branches hang towards the ground and may require pruning for public safety. It will be necessary to take caution when pruning as to not throw off the balance and stability of the tree. Where design modifications to achieve 10 ft of distance are not feasible, survivability may be significantly higher if the tree is protected in place with less than 10 ft of clearance. Pruning and modifications to the design are highly preferred over removal or attempting transplant. This tree flowered in the last couple years and is contributing to the seed bank.

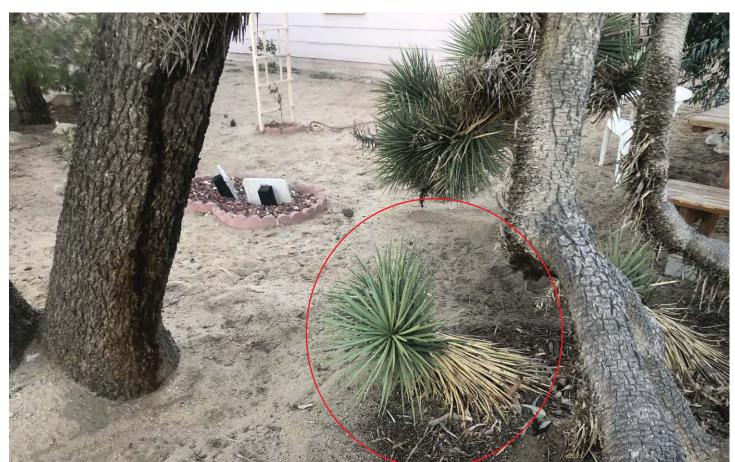
PLANT NUMBER: 2

STATUS (TRANSPLANT, DESTROY, PROTECT): Protect *outside of ROW on private property

DECAY OR DAMAGE: None

ROOT FLARE CONDITION: Ok. Some mounding on corner makes it hard to see the root flare.

TRANSPLANT FEASIBILITY NOTES: Feasible, but it is not recommended as attempting transplant will likely damage the roots of tree #1. This appears to be a separate tree as the base of the plant is more than 1 meter from the largest trunk. The tree is tucked underneath what appears to be the low hanging branches of tree #1 that may have rooted in the ground. It is not possible determine root connections without further inspection. OTHER NOTES & RECOMMENDATIONS: Where design modifications to achieve 10 ft of distance are not feasible, survivability may be higher if the tree is protected in place with less than 10 ft of clearance.

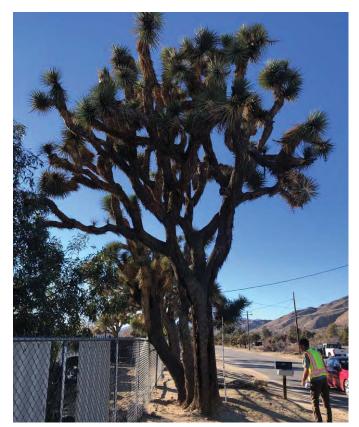
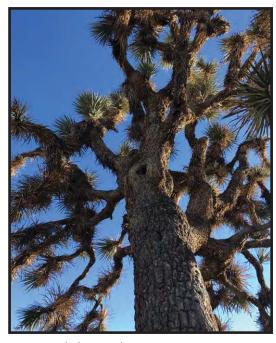
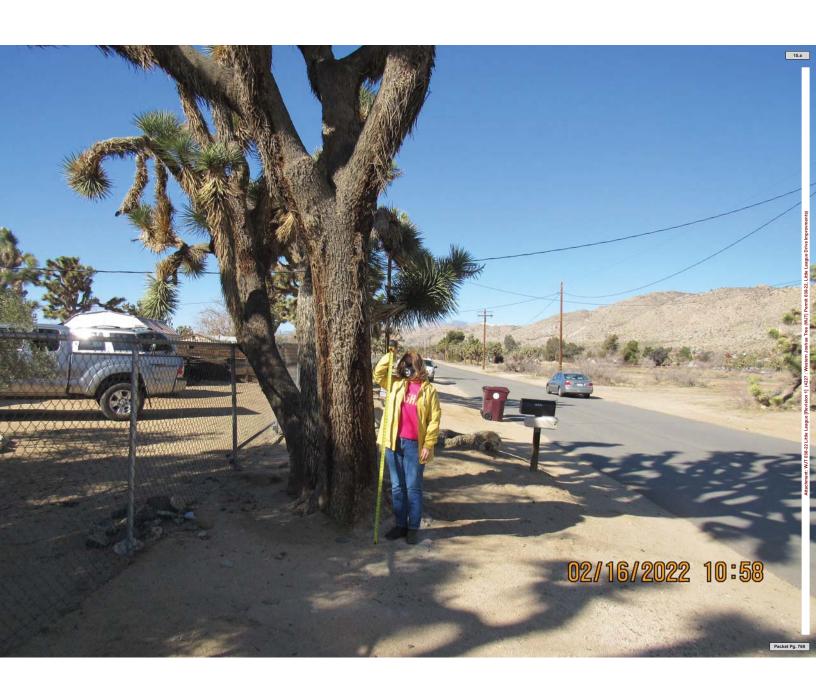
PLANT NUMBER: 3

STATUS (TRANSPLANT, DESTROY, PROTECT): Destroy **

DECAY OR DAMAGE: A few holes in trunk, likely due to age, and some woodpecker damage

TRANSPLANT FEASIBILITY NOTES: This is tree is a very old and large specimen and it is likely not possible to transplant successfully. It would be very expensive and difficult to move with equipment and survival may be low. It may be worth considering boxing this tree to move it as it would be a challenge to move with a tree spade. It is not recommended to remove nor transplant this tree, instead it is strongly advised to explore ways in which the work can be modified to protect the tree in place. The tree has flowered in the last 2 years and is contributing to the seed bank.

OTHER NOTES & RECOMMENDATIONS: It is unclear if the depth of grading at this location can be modified as it appears to be almost 2 ft on the plans, yet it would be preferred to conduct work closer than 10 ft as needed in order to leave the tree in place. Consult with a competent contractor regarding the root structure of this tree for further assessment to determine relocation methods and equipment.

Some trunk damage here

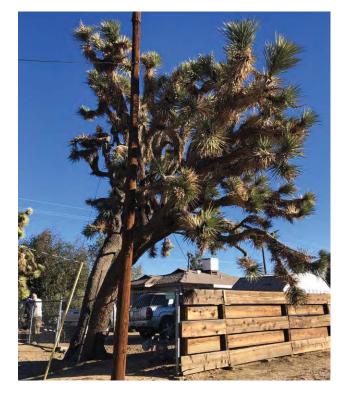
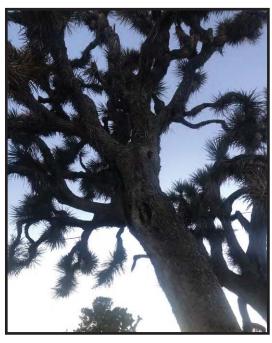
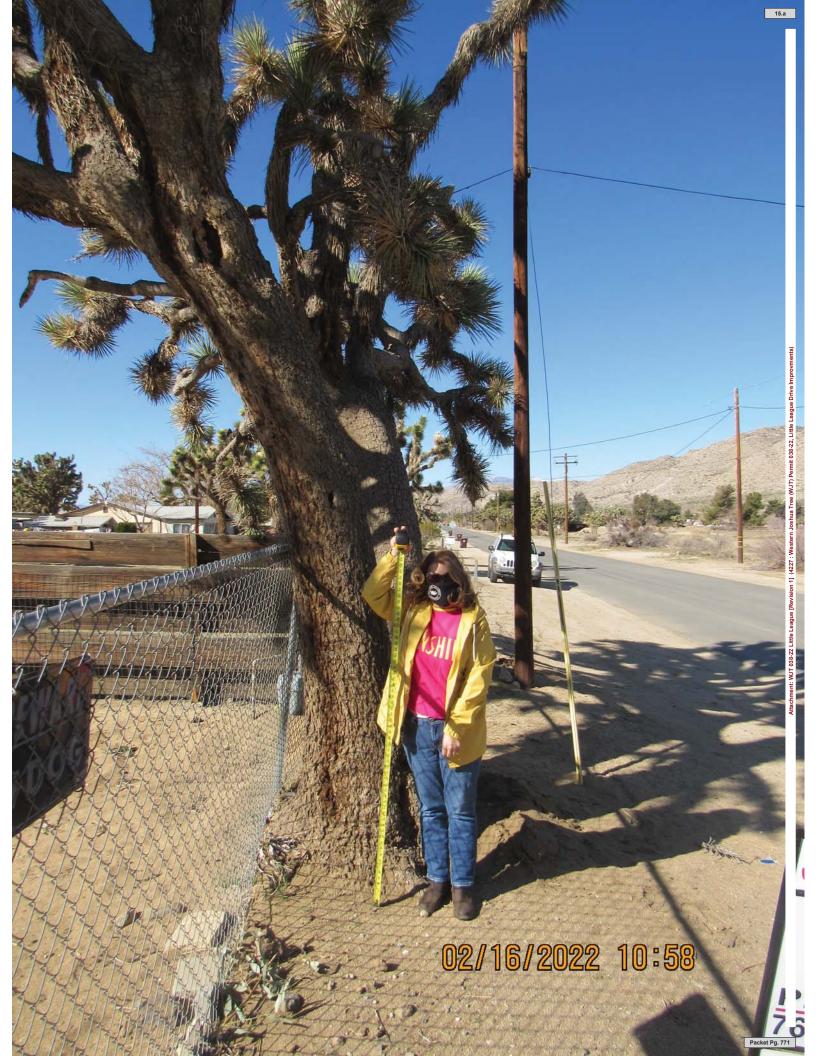
PLANT NUMBER: 4

STATUS (TRANSPLANT, DESTROY, PROTECT): Destroy **

DECAY OR DAMAGE: Some woodpecker holes, some other scars due to age and fallen branches

TRANSPLANT FEASIBILITY NOTES: TRANSPLANT FEASIBILITY NOTES: This is tree is a very old and large specimen and it is likely not possible to transplant successfully. It would be very expensive and difficult to move with equipment and survival may be low. It is not recommended to remove nor transplant this tree, instead it is strongly advised to explore ways in which the work can be modified to protect the tree in place. It may be worth considering boxing this tree to move it as it would be a challenge to move with a tree spade. Proximity to the power line is of concern for equipment.

OTHER NOTES & RECOMMENDATIONS: It is unclear if the depth of grading at this location can be modified as it appears to be almost 2 ft on the plans, yet it would be preferred to conduct work closer than 10 ft as needed in order to leave the tree in place. Consult with a competent contractor regarding the root structure of this tree for further assessment. This tree has more damages than #3, but it's leaves are healthy, it is growing, and contributing to the seed bank.

Some trunk damage here

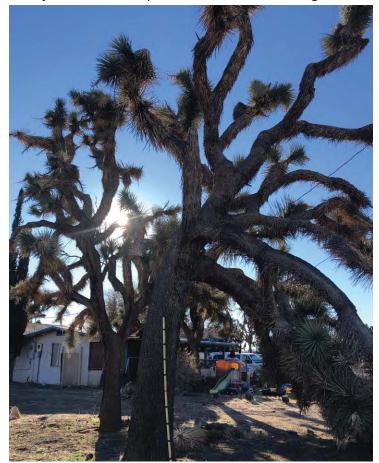
PLANT NUMBER: 5

STATUS (TRANSPLANT, DESTROY, PROTECT): Protect (outside of ROW on private property)

NUMBER OF PUPS: 0 MAX HEIGHT OF TALLEST PUP: NA DECAY OR DAMAGE: Some thatch missing on branches and trunk at the start of the joints

ROOT FLARE CONDITION: Good, mounded, and some rodent holes

TRANSPLANT FEASIBILITY NOTES: This is tree is a very old and large specimen and it is likely not possible to transplant. It would be very expensive and difficult to transplant and survival may be low. Given the location from ROW it will be possible to maintain more than 10 ft distance from this tree.

OTHER NOTES & RECOMMENDATIONS: Pruning may be recommended prior to work as well as for public safety reasons as there are several branches that are growing low to the ground. Branches should be cut back to the main joint, however a significant amount of pruning may throw the balance of this tree off and one should exercise caution when pruning to maintain stability of the tree. This tree is included because work may occur adjacent to the drip line of this tree. Pruning recommendations are for the private owner.

Some pruning may be recommended to maintain public safety and safety while working. Consult with a tree pruning expert.

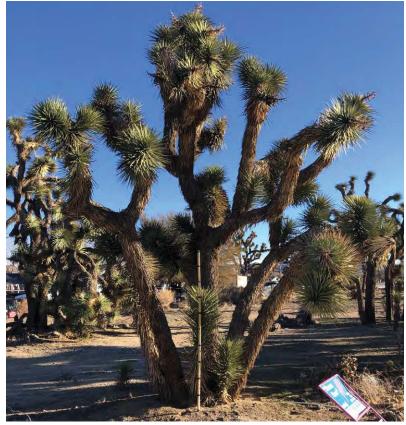
PLANT NUMBER: 6

STATUS (TRANSPLANT, DESTROY, PROTECT): Destroy ***

DECAY OR DAMAGE: Some thatch on the trunk is missing

TRANSPLANT FEASIBILITY NOTES: Given overall size and number of pups this tree may be very difficult and expensive to move and it may not survive transplant. It would require extensive wooden framing to support the pups and branches. It may be worth considering boxing this tree to move it as it would be a challenge to move with a tree spade. This is a very healthy large tree that is contributing to the seed bank, if at all possible to leave in place and conduct work closer than 10 ft that would be preferred over attempting transplant.

OTHER NOTES & RECOMMENDATIONS: The Town requires that work be 10 ft away from the center of the tree, however based on the site visit with the Inspector, it appears that the edge of the sidewalk ends somewhat close to the base of this tree. There is very minimal grade change here possibly less than 6 inches. The tree can likely survive if minimal grading occurs adjacent to it and it has a significantly less of a chance of surviving transplant.

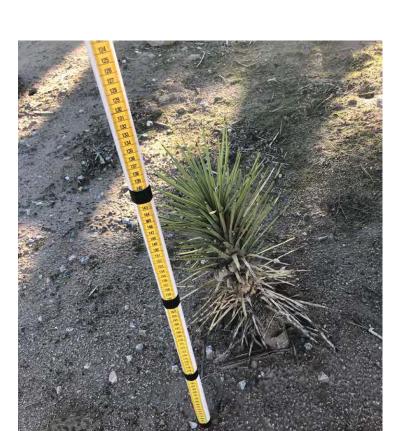
PLANT NUMBER: 7

STATUS (TRANSPLANT, DESTROY, PROTECT): Transplant

ROOT FLARE CONDITION: Ok, some erosion

TRANSPLANT FEASIBILITY NOTES: Feasible given size, however it is not impossible that this pup is connected to the main plant given how vigorous #6 is growing, however it is located 1.6 m from the main trunk.

This plant is more than 1 meter from the main plant

OTHER NOTES & RECOMMENDATIONS: If possible to protect in place given sidewalk shifts that would be

preferred given that it is not impossible this plant is connected to #6. Plant may require caging to protect it from herbivores when relocated.

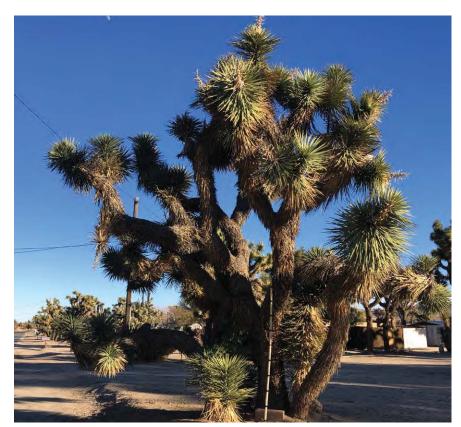
PLANT NUMBER: 8

STATUS (TRANSPLANT, DESTROY, PROTECT): Destroy **

DECAY OR DAMAGE: Some thatch loss due to age

ROOT FLARE CONDITION: Good, some rodent holes near the base

TRANSPLANT FEASIBILITY NOTES: Given overall size and number of pups this tree may be very difficult and expensive to move and it may not survive transplant. It may be worth considering boxing this tree to move it as it would be a challenge to move with a tree spade. This is a very healthy large tree that is contributing to the seed bank, if at all possible to leave in place and conduct work closer than 10 ft that would be preferred over attempting transplant.

OTHER NOTES & RECOMMENDATIONS: The Town requires that work be 10 ft away from the center of the tree, however based on the site visit with the Inspector, it appears that the edge of the sidewalk is near but there is some space from the base of this tree. There is very minimal grade change here possibly less than 6 inches. The tree can likely survive if minimal grading occurs adjacent to it and it has a significantly less of a chance of surviving transplant. Prune branches up for public safety if required.

All pups appear to be within 1 meter of the main trunk
