YUCCA TRAIL SAFETY ANALYSIS: IMMEDIATE IMPROVEMENTS

PREPARED FOR:
THE TOWN OF YUCCA VALLEY

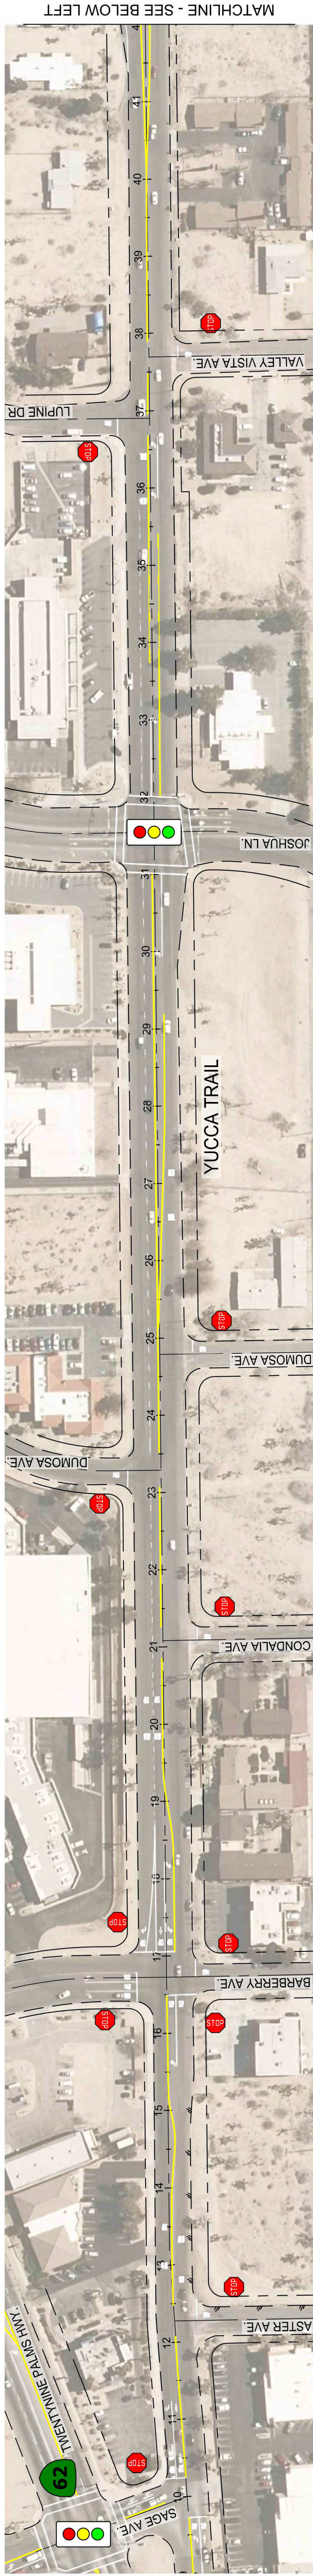
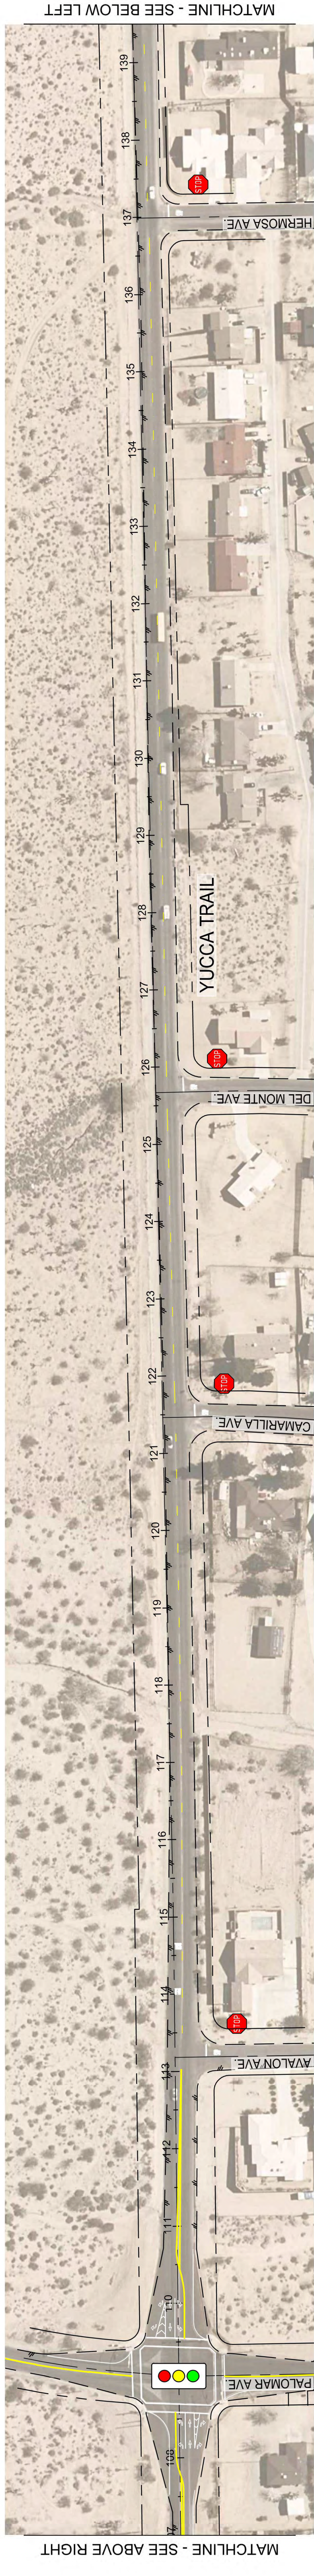
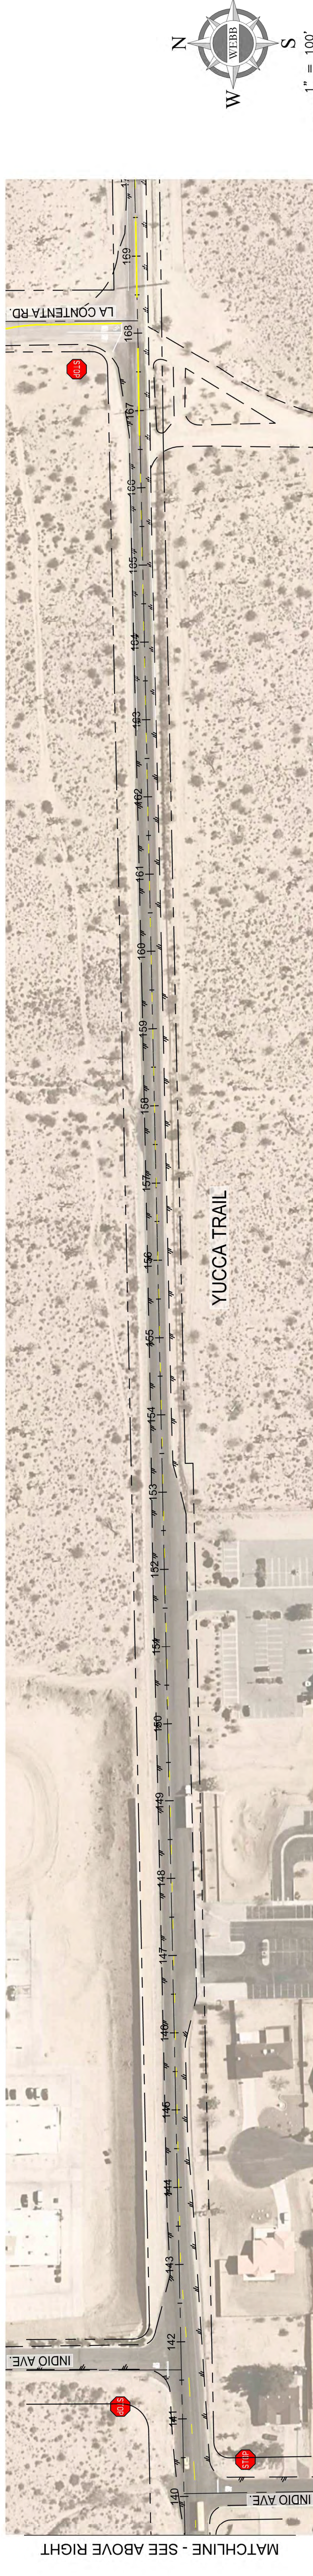
**YUCCA TRAIL SAFETY ANALYSIS
SAGE AVENUE TO LA CONTENTA ROAD
EXISTING GEOMETRY AND CONTROL**

The existing traffic control and intersection geometrics of the study area are shown on Figure 3-A.

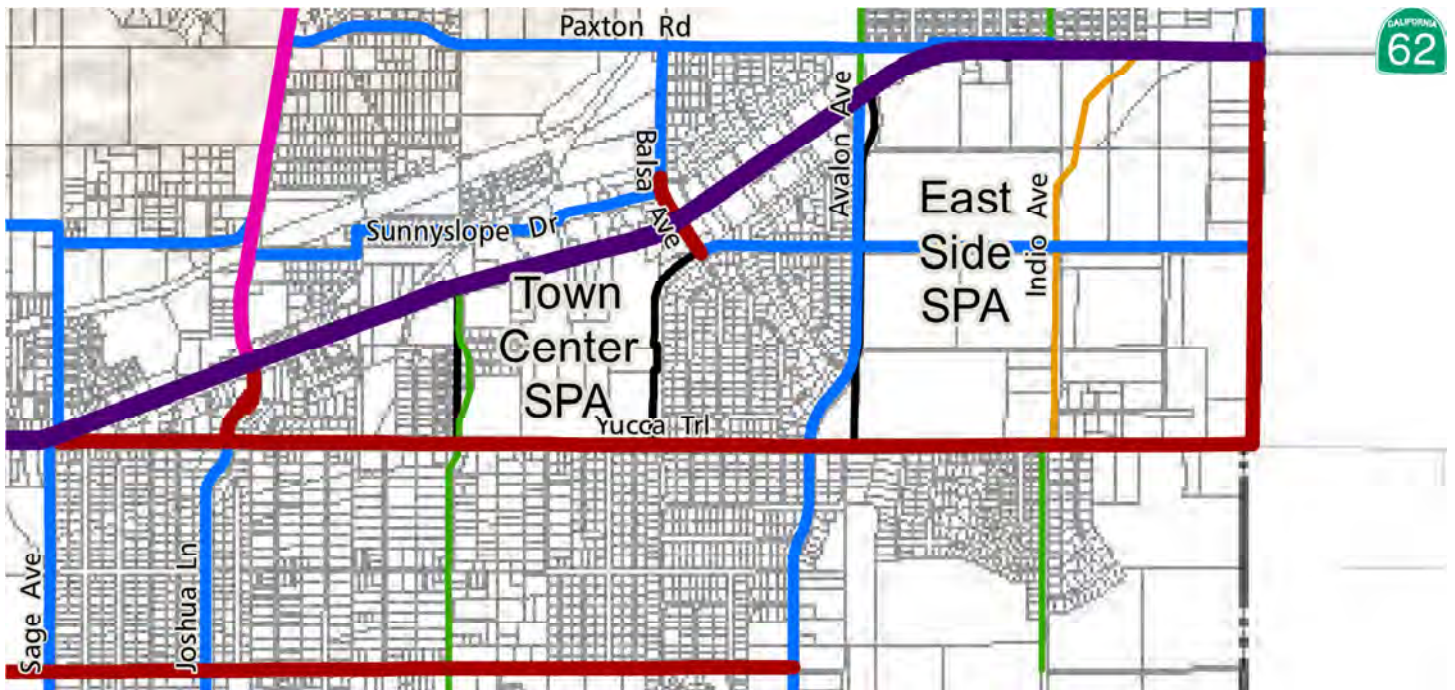
Figure 3-C – General Plan Roadway Classification at General Plan Buildout

-   Highway – 6 Lanes Divided – 134'
-   Highway – 4 Lanes Divided – 92'
-   Arterial – 4 Lanes Divided – 100'
-   Arterial – 2 Lanes – 70'
-   Industrial – 2 Lanes with Striped Median – 70'
-   Collector – 2 Lanes – 66'
-   SPA - Special Policy Area
-   Town Limits

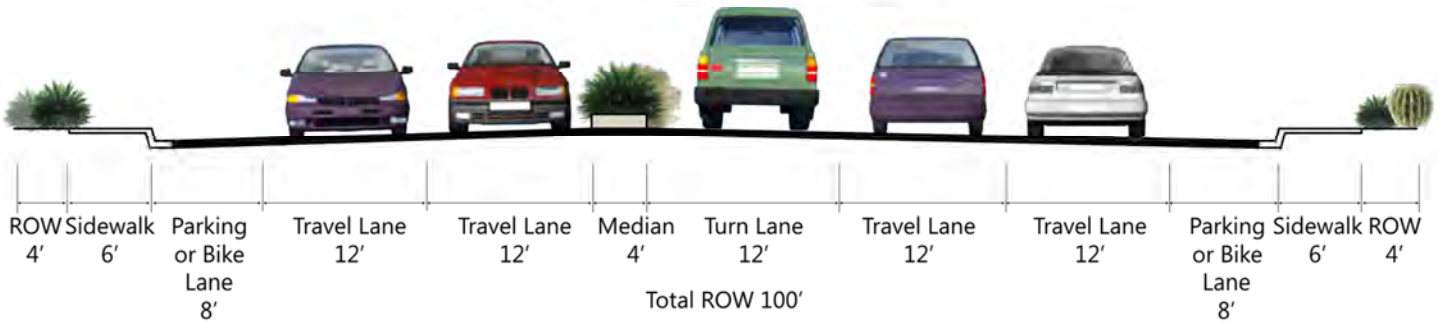
ARTERIAL - 4 LANES DIVIDED

The General Plan Roadway Cross-Section for Yucca Trail includes four travel lanes (4x12'), a raised median/turn lane (16'), shoulders for parking or bike lane on each side (2x8'), sidewalks on each side (2x6'), and landscaping on each side (2x4'). The total right-of-way required for this cross-section is 100'.

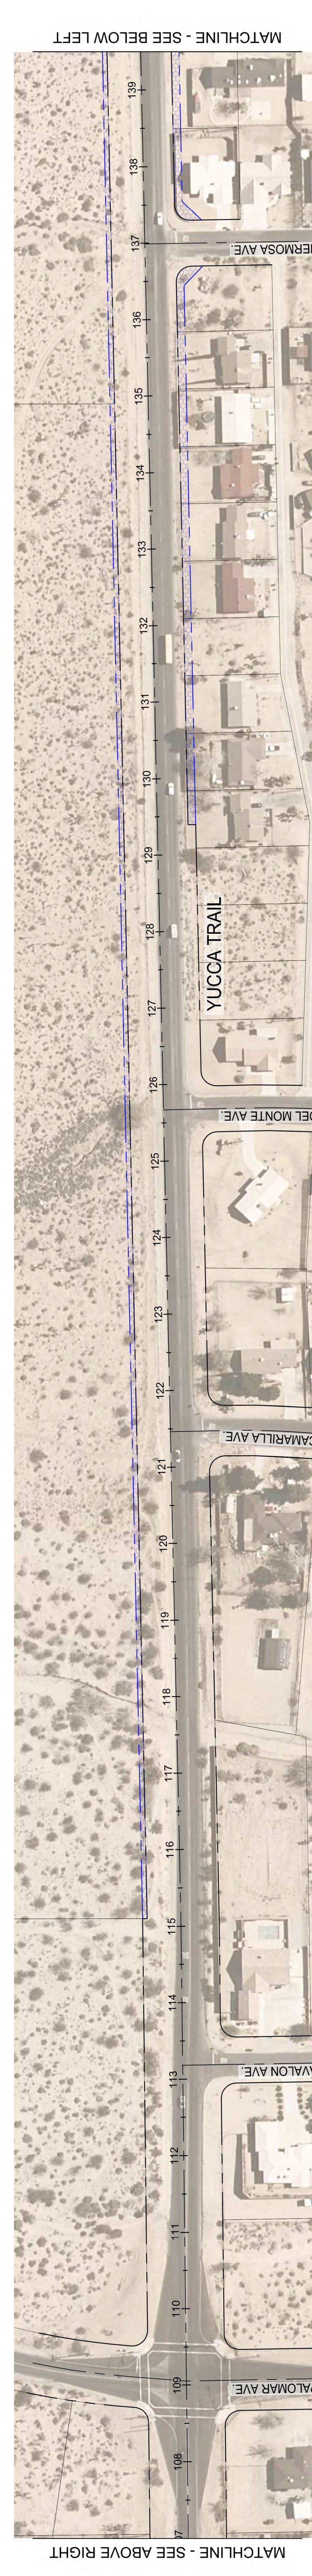
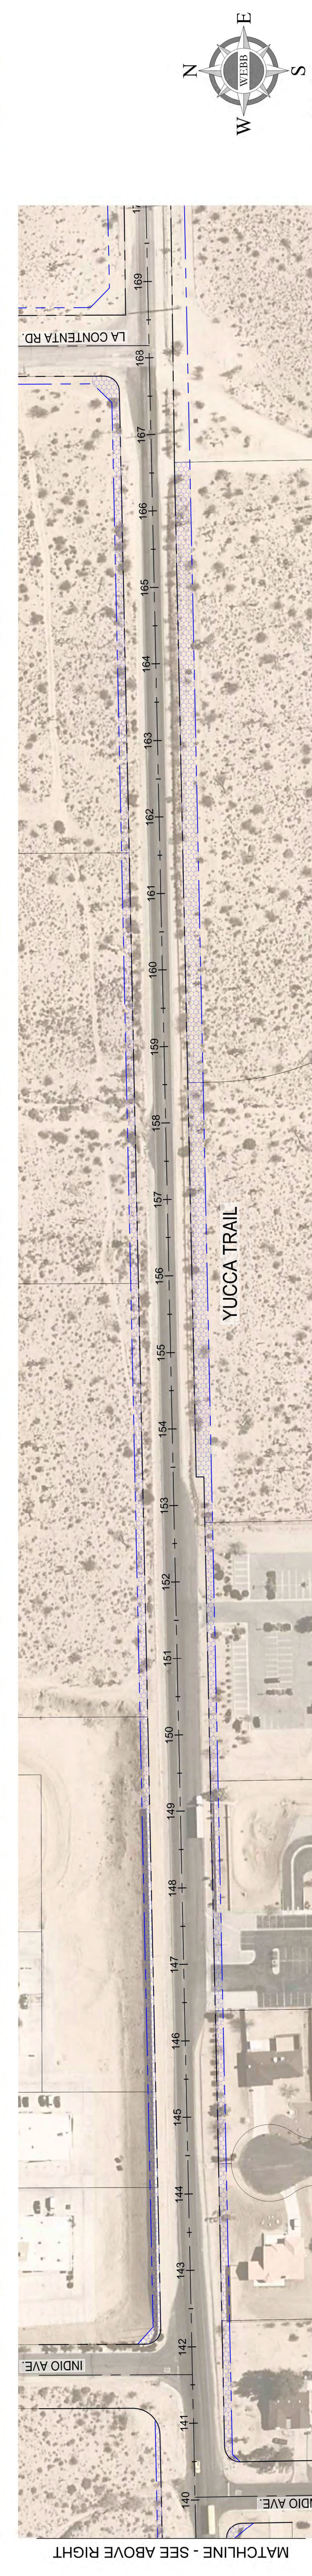
An analysis of right-of-way requirements to widen Yucca Trail to 4 lanes is provided on Exhibit 4-A. This analysis is preliminary and based on GIS/APN map data only in order to give an idea of the amount of right-of-way required to build the ultimate roadway section. As shown in the exhibit, most of the needed right-of-way does not look like it will impact existing development except between Sage Avenue and Barberry Avenue. In order to acquire the ultimate right-of-way for this segment, significant impacts will occur to existing development on both the north and south side of Yucca Trail.

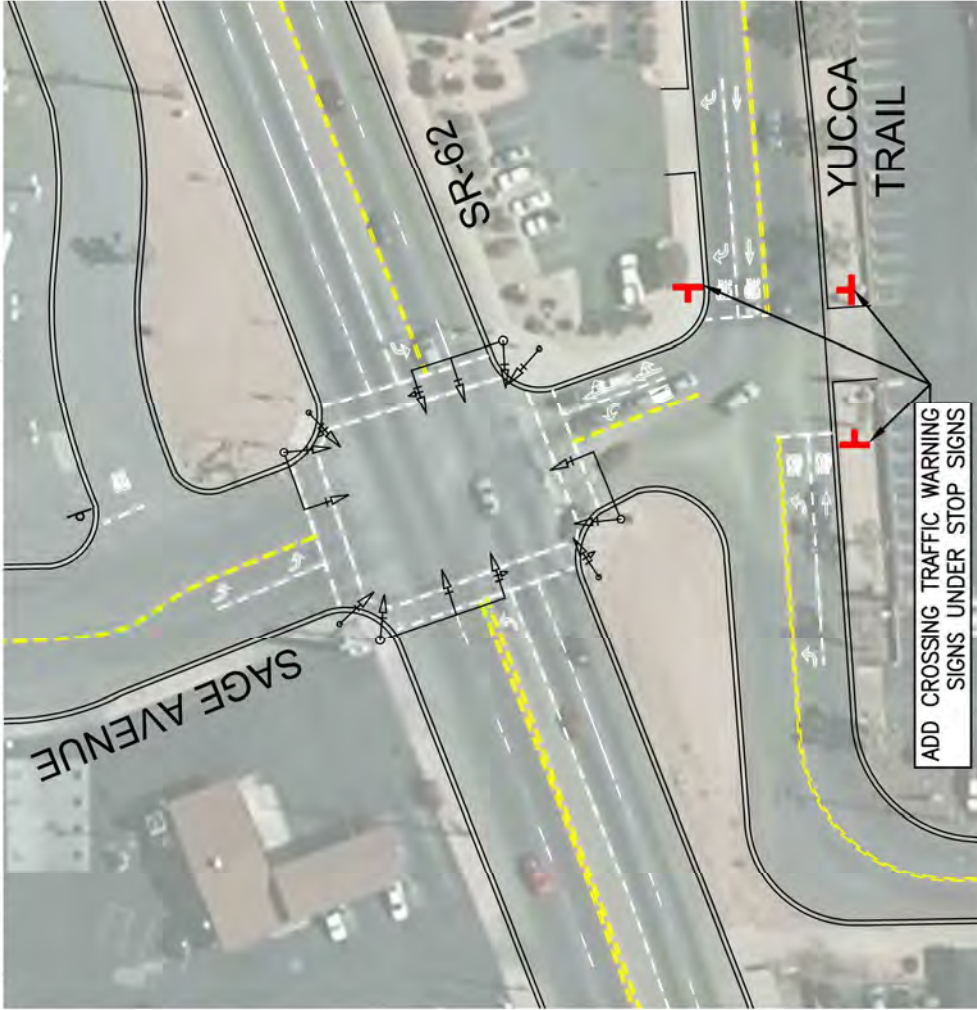
Figure 5-A – Short Range Recommendation – Sage Avenue & Yucca Trail

ADD CROSSING TRAFFIC WARNING SIGNS UNDER STOP SIGNS

- Add “TRAFFIC FROM LEFT DOES NOT STOP” plaque [W4-4aP(LT)] to stop sign for eastbound direction.
- Add “ONCOMING TRAFFIC DOES NOT STOP” plaque (W4-4bP) to stop sign for northbound direction.
- Refresh all existing striping & markings with thermoplastic to improve visibility.
- Cost Estimate: \$3000

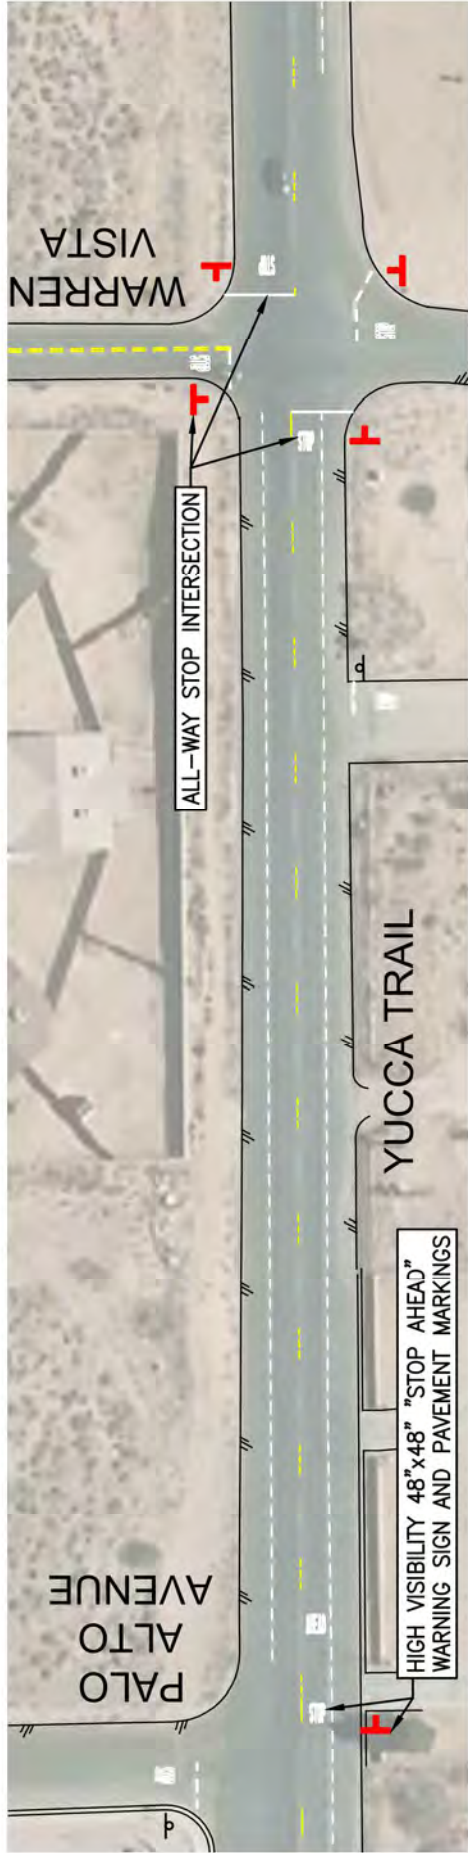
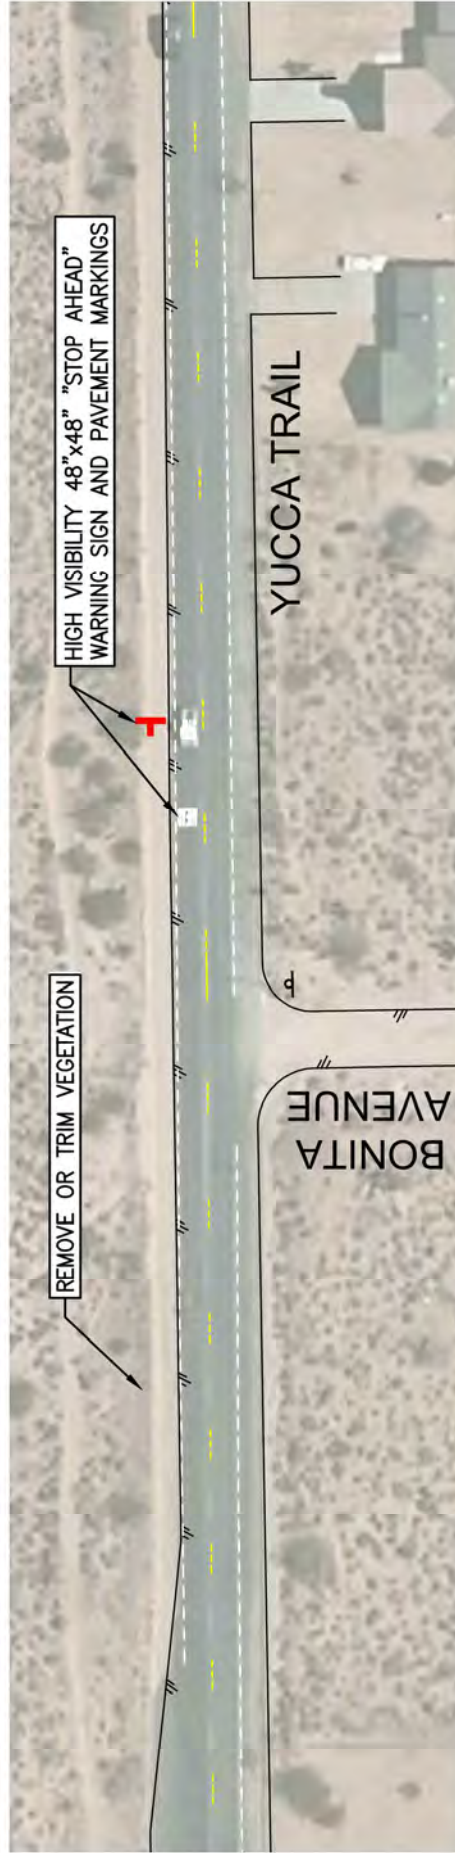
Figure 5-B – Short Range Recommendation – Warren Vista Avenue & Yucca Trail

- Convert intersection to all way stop in interim condition. This will require stop signs (R1-1), all way plaques (R1-3P), and stop ahead warning signs (W3-1) for eastbound and westbound directions. This will also require all way plaques (R1-3P) for northbound and southbound directions. Oversized signs, flashing beacons, and/or Light Emitting Diode (LED) enhanced signs along Yucca Trail are recommended to improve visibility and compliance.
- Add “Stop Ahead” pavement markings adjacent to stop ahead warning signs for eastbound and westbound directions.
- Remove or trim vegetation to increase sight distance to the east.
- Refresh existing striping & markings with thermoplastic to improve visibility.
- Perform public outreach and education before significant changes to traffic control.
- Cost Estimate: \$7000

- Convert intersection to all way stop in interim condition. This will require stop signs (R1-1), all way plaques (R1-3P), and stop ahead warning signs (W3-1) for eastbound and westbound directions. This will also require all way plaques (R1-3P) for northbound and southbound directions. Oversized signs, flashing beacons, and/or Light Emitting Diode (LED) enhanced signs along Yucca Trail are recommended to improve visibility and compliance.
- Add “Stop Ahead” pavement markings adjacent to stop ahead warning signs for eastbound and westbound directions.
- Remove or trim vegetation to increase sight distance to the east.
- Refresh existing striping & markings with thermoplastic to improve visibility.

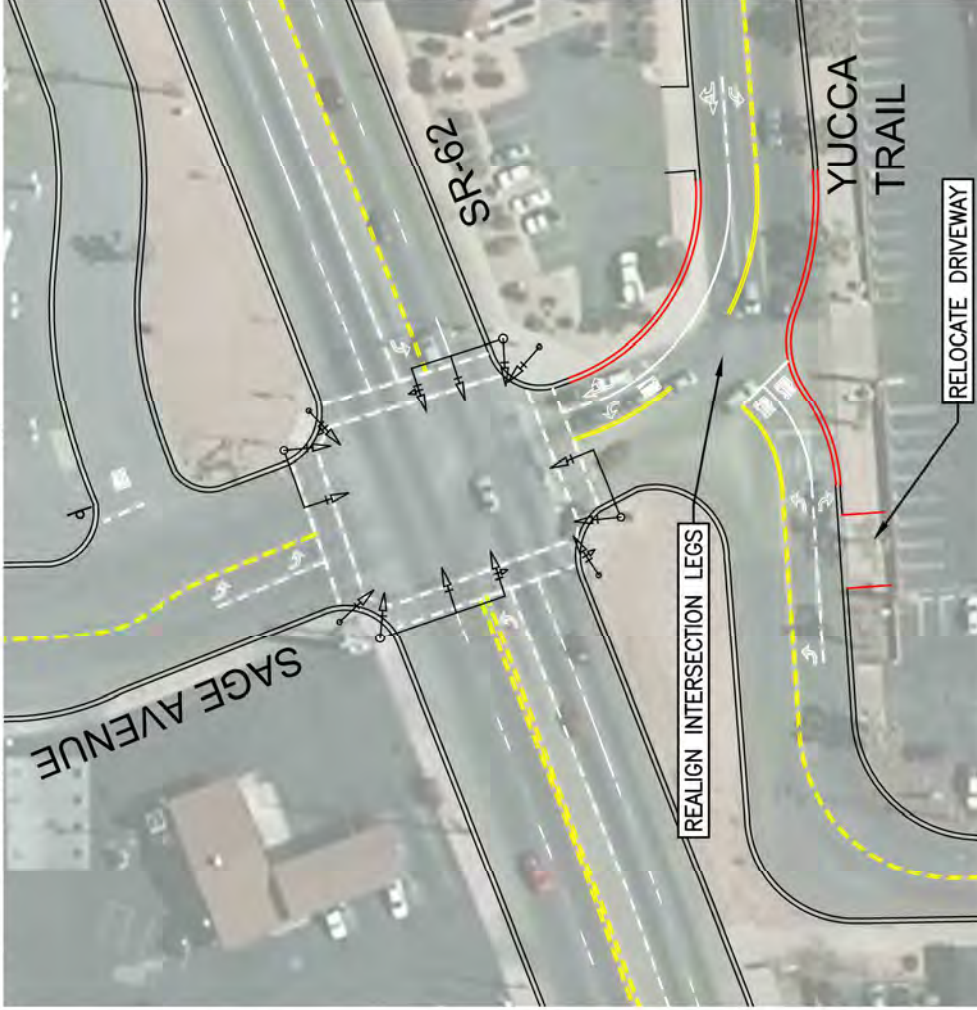
Figure 5-D – Mid-Range Recommendation – Sage Avenue & Yucca Trail (Option 1)

- Realign Yucca Trail and Sage Avenue such that the north leg and east leg are the major/through movements and the west leg is the minor/side movement. The south leg (commercial driveway) will need to be closed or relocated to the west to access the minor leg of the intersection.
- This option may impact the parking lot of the property on the northeast corner of the intersection (KFC)

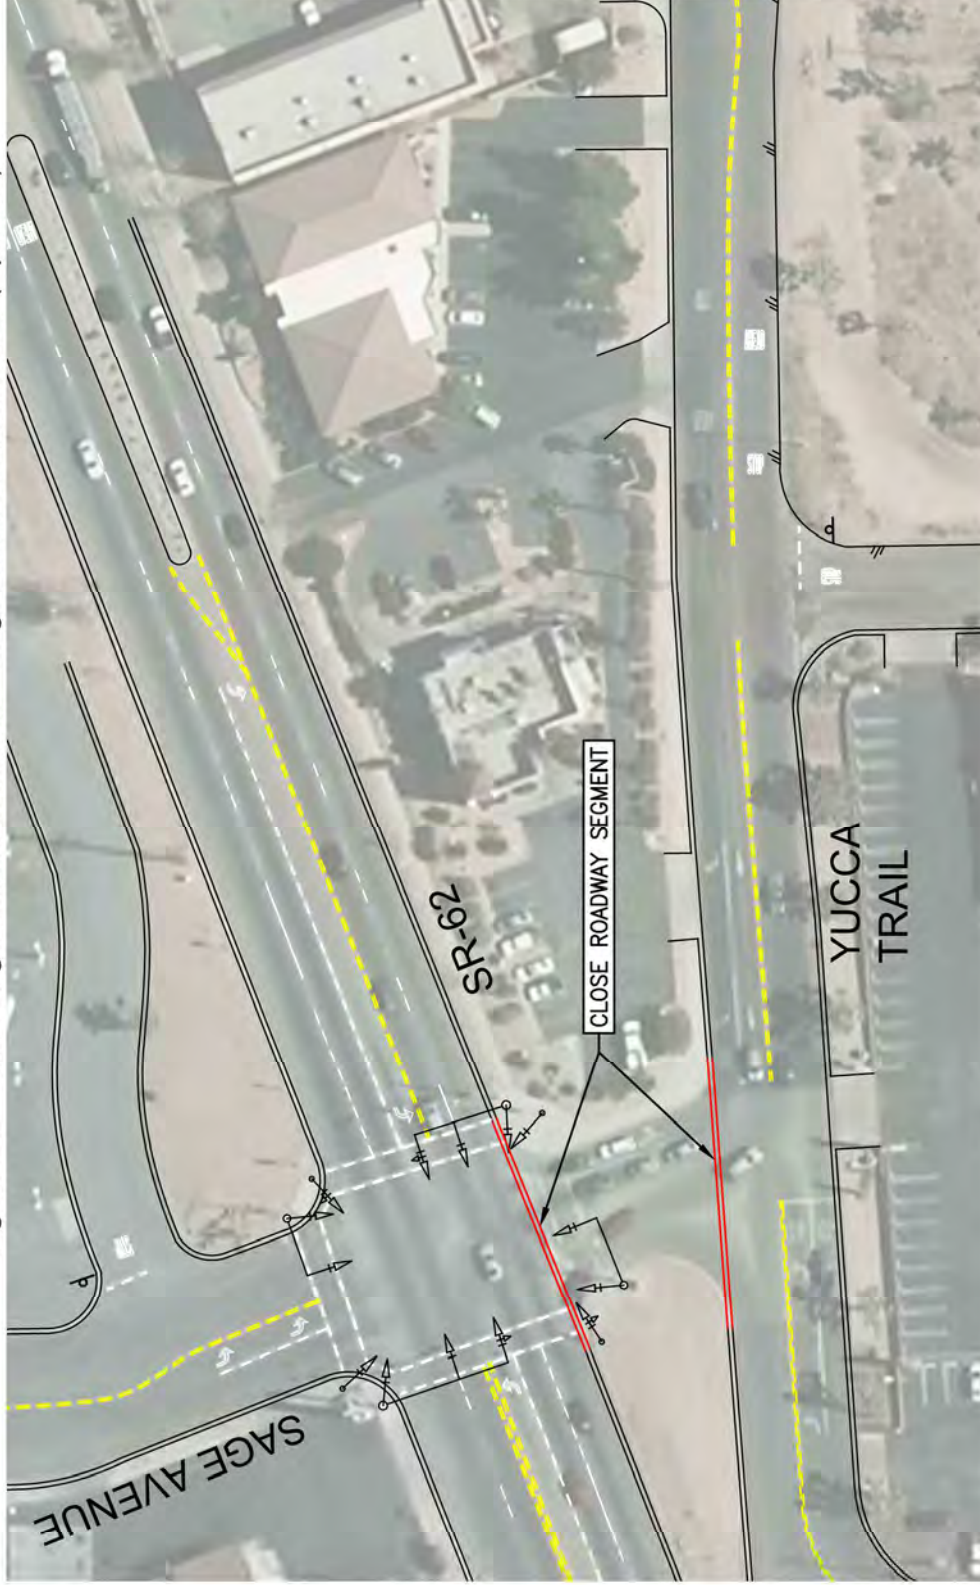
Figure 5-E – Mid-Range Recommendation – Sage Avenue & Yucca Trail (Option 2)

- Close Sage Avenue between Yucca Trail and Twentynine Palms Highway (SR-62).
- Traffic will be rerouted to Barberry Avenue or Dumosa Avenue. A new traffic signal may be required at Barberry Avenue/Twentynine Palms Highway (SR-62) and/or at Barberry Avenue/Yucca Trail.

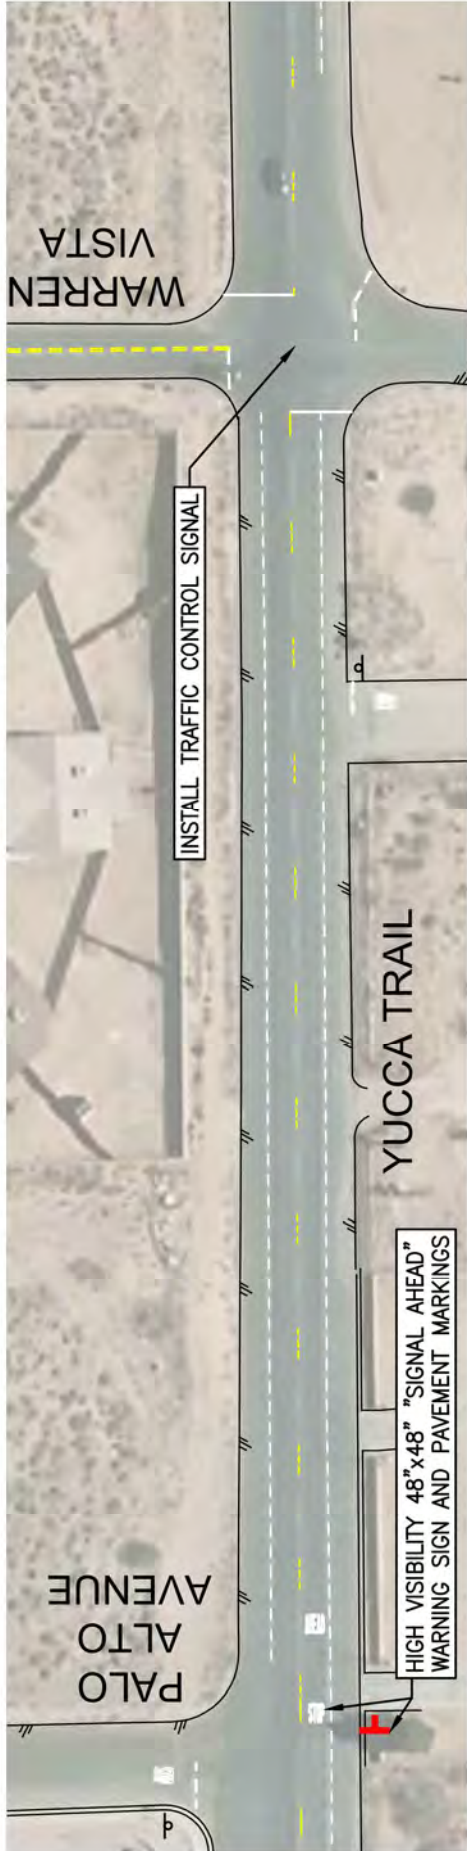
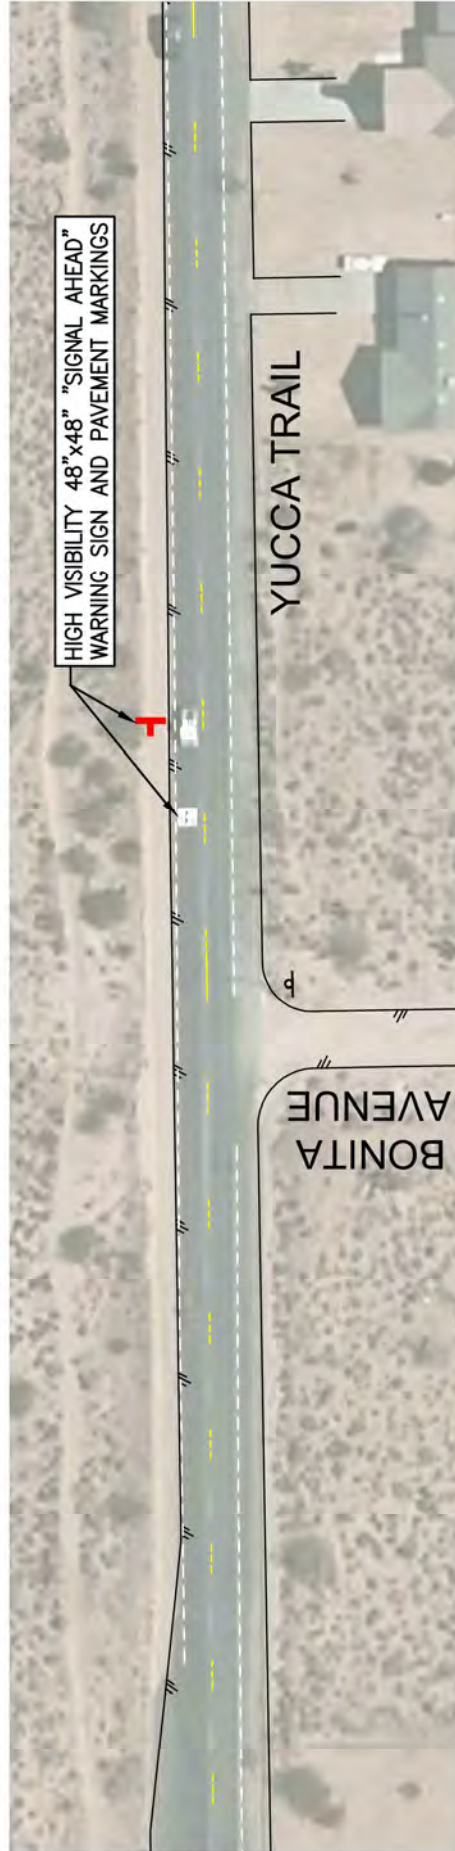
Figure 5-F – Mid-Range Recommendation – Warren Vista Avenue & Yucca Trail

- Install traffic control signal for ultimate condition. This will require replacing all stop ahead warning signs (W3-1) and pavement markings with signal ahead warning signs (W3-3) and pavement markings. Oversized signs, flashing beacons, and/or Light Emitting Diode (LED) enhanced signs along Yucca Trail are recommended to improve visibility and compliance.
- Cost Estimate: \$250,000

- Install traffic control signal for ultimate condition. This will require replacing all stop ahead warning signs (W3-1) and pavement markings with signal ahead warning signs (W3-3) and pavement markings. Oversized signs, flashing beacons, and/or Light Emitting Diode (LED) enhanced signs along Yucca Trail are recommended to improve visibility and compliance.
- Cost Estimate: \$250,000

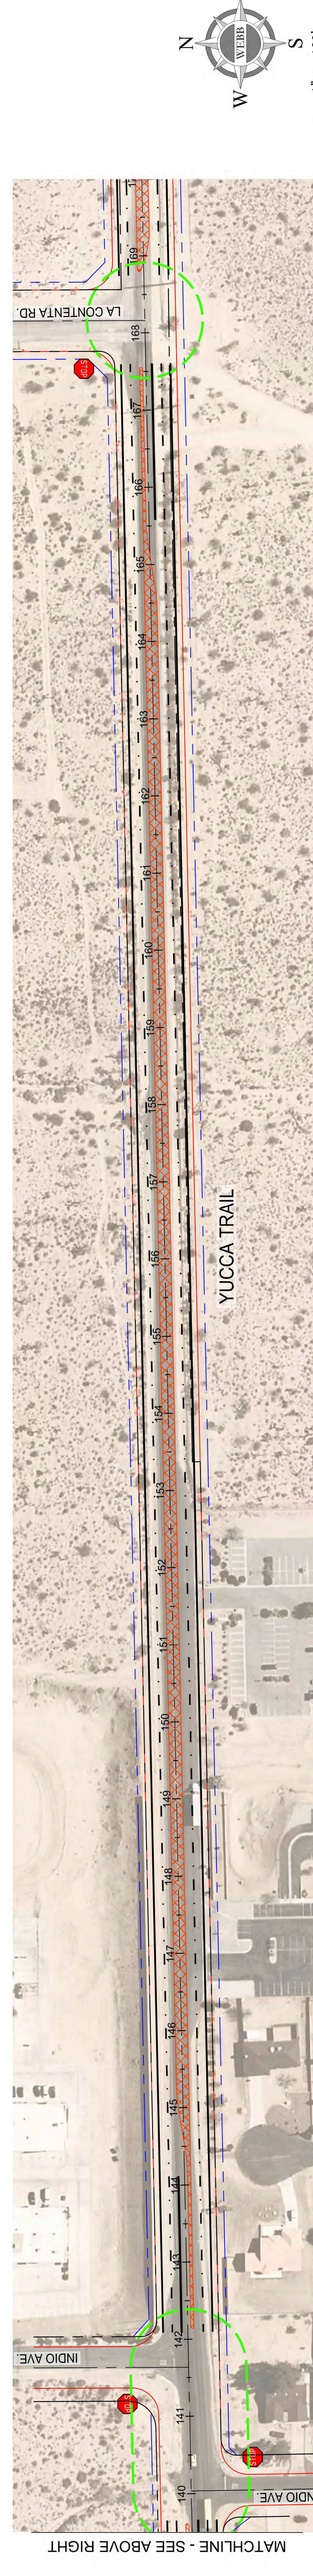
**YUCCA TRAIL SAFETY ANALYSIS
SAGE AVENUE TO LA CONTENTA ROAD
GENERAL PLAN BUILDOUT EXHIBIT**

Table 5-1 and Exhibit 5-A present the existing and recommended traffic control, median openings, and circulation recommendations along Yucca Trail between Sage Avenue and La Contenta Road for ultimate conditions.
