Town of Yucca Valley
PLANNING COMMISSION STAFF REPORT

Subject: Western Joshua Tree (WJT) Permit 037-22, Onaga Trail (Acoma Trail to Palm Avenue), Yucca Valley CA.; Transplant One (1) Western Joshua Tree, Remove One (1) Dead Western Joshua Tree

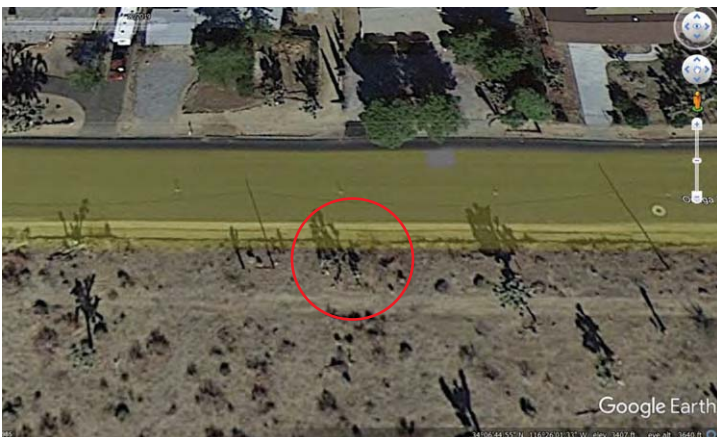
Google Earth Dec 2019

OTHER NOTES & RECOMMENDATIONS: On the plans there is a Joshua Tree identified at APN 0587-011-06 adjacent to a power pole and across the street from APN 0587-342-12. Given the location on the plans, this is our best guess as to where there might have been a tree. There is a significant hole next to the *Senegalia greggii* and *Cylindropuntia echinocarpa*. There is no tree present to date. There is some Joshua Tree branches and thatch on the ground behind the shrub, but due to the decay it doesn't appear to be recent damage. In Google Earth imagery from 2019 shows what appears to be a Joshua Tree. Activity and cause of death is unknown.

Above: Some old Joshua Tree branches and thatch on the ground, they do not appear to be of recent death.

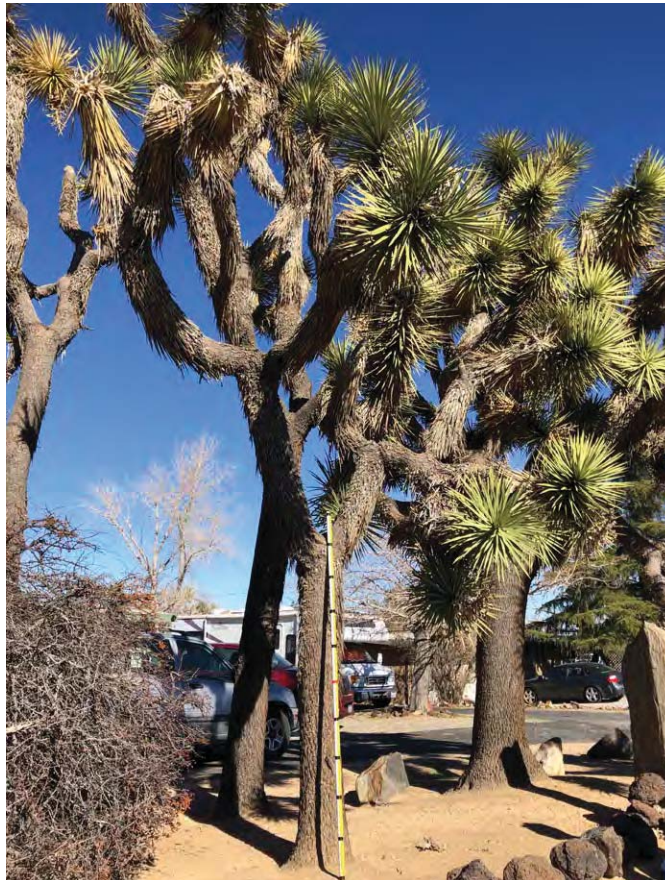
TRANSPLANT FEASIBILITY NOTES: Feasible, although not recommended. This tree may be difficult to frame and keep branches from snapping while moving. Also the digging necessary to transplant this tree will likely cause damage to the root system of the adjacent tree #7 and the two trees behind it.

OTHER NOTES & RECOMMENDATIONS: Although the Town requires that work be 10 ft away from the center of the tree, based on the site visit with the Inspector, it appears work may occur close to 7 ft from the plant. Since the drip line extends approximately 6.5 ft and the depth of work may only be a few inches, it is preferred to conduct grading within 7 ft of the plant over attempting transplant of this tree. The tree can likely survive if minimal grading occurs adjacent to it and it has less of a chance of surviving transplant to a new location. This plant flowered recently and is contributing to the seed bank.

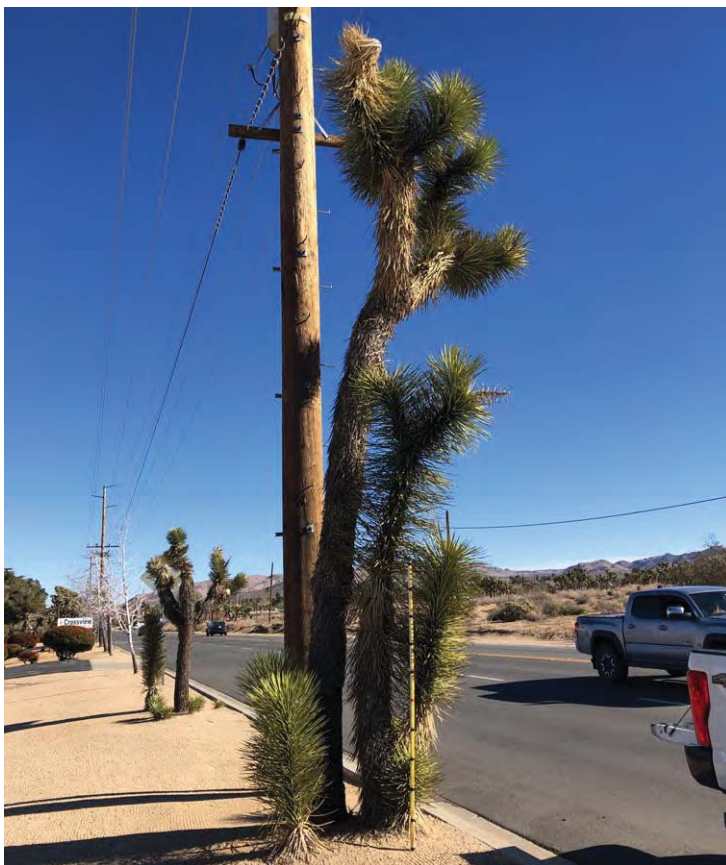
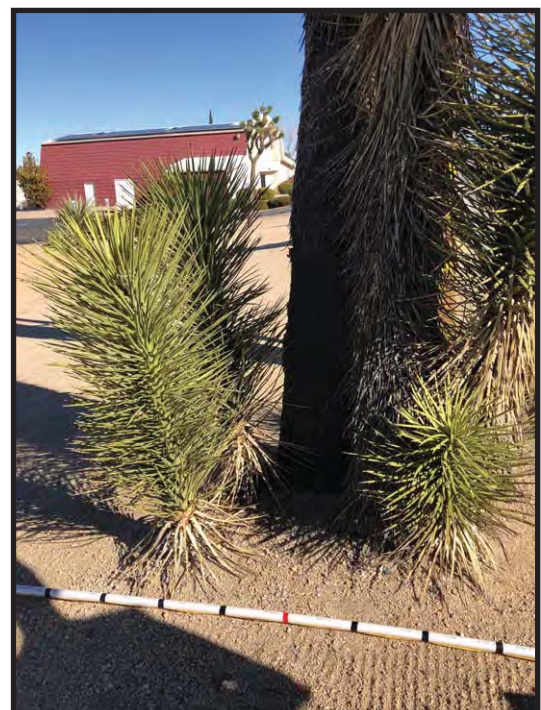
All pups within 1 meter of the main trunk

TRANSPLANT FEASIBILITY NOTES: Possible, but this tree is very tall, has quite a few pups, and it's proximity to the power pole may create a significant challenge for excavation and transplant. Given curb and road work, it is unknown if previous ground work cut roots on the south side.

OTHER NOTES & RECOMMENDATIONS: Within the ROW it may be difficult to modify work and maintain 10 ft of distance from the tree. Grading appears to be only a few inches and if work can stay off the drip line radius, it is recommended to leave the plant in place as it is likely to survive minimal damage to a portion of the root system. Joshua Trees in general do not transplant well and whenever it is possible to modify work, the survival of the tree long-term will be higher than transplanting it to a new location. Please consult with contractors to determine if this tree is possible to transplant with equipment given size and power lines.

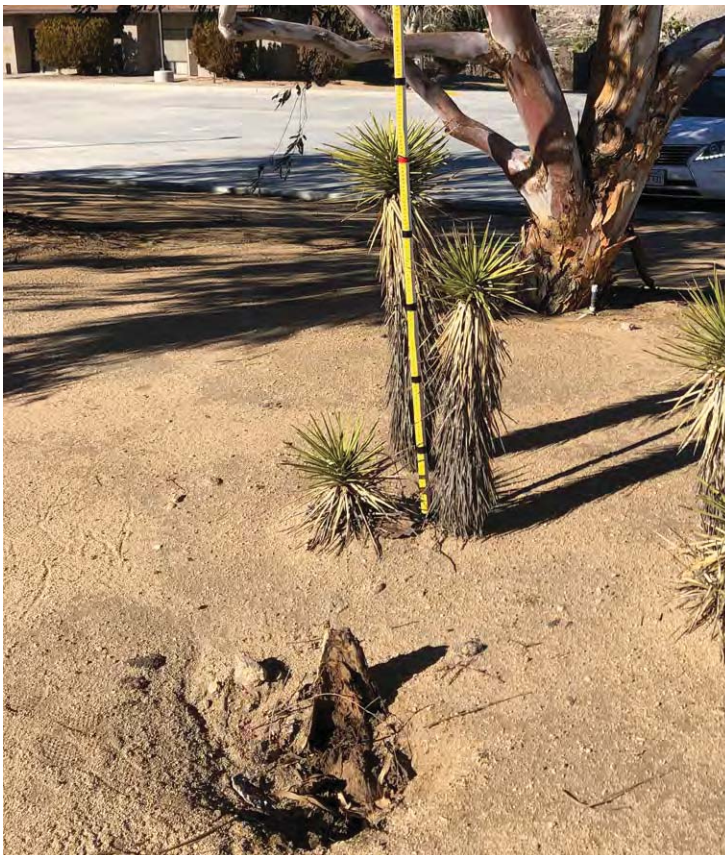
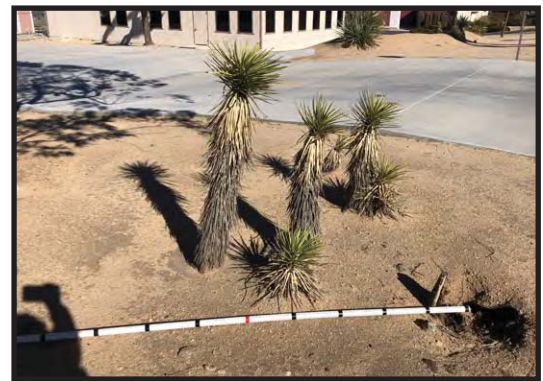
All pups within 1 meter of the main trunk

TRANSPLANT FEASIBILITY NOTES: Feasible given size. However, #13 & #14 are difficult to determine if they are all pups from the dead trunk or if they are separate plants. They have been separated here because the tallest branch is more than 1 meter from the dead trunk and 1.2 meters from the tallest branch of #14, but it could be possible they are all connected as one plant. If they are all connected, transplant may be less successful if the root system is divided and the dead trunk's root system is significantly disturbed.

OTHER NOTES & RECOMMENDATIONS: Since these are outside of the ROW, it is best to leave in place and work around. Based on the plans and walk with the inspector it appears that grading is very minimal, perhaps only a few inches and work is approximately 2 meters from these plants, that should be plenty of room to stay off the drip line and not cause significant disturbance even if work occurs within 10 ft.

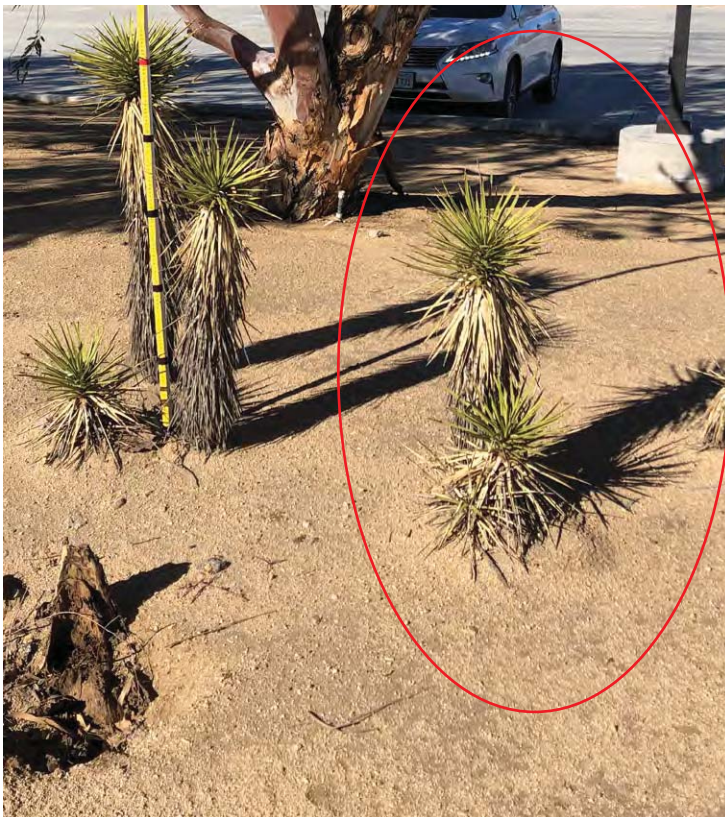
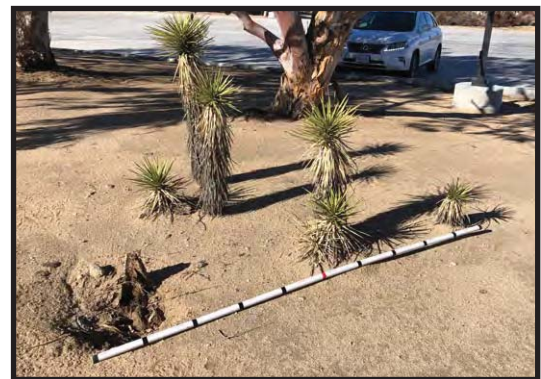
All pups within 1 meter of the main trunk

TRANSPLANT FEASIBILITY NOTES: Feasible given size. However, #13 & #14 are difficult to determine if they are all pups from the dead trunk or if they are separate plants. They have been separated here because the tallest pup is more than 1 meter from the dead trunk and 1.2 meters from the tallest branch of #13. However, it could be possible they are all connected as one plant coming from the main dead trunk. If they are all connected transplant may be less successful if the root system is divided.

OTHER NOTES & RECOMMENDATIONS: Since these are outside of the ROW, it is best to leave in place and work around. Based on the plans and walk with the inspector it appears that grading is very minimal, perhaps only a few inches and work is approximately 1-2 meters from these plants, that should be plenty of room to stay off the drip line not cause significant disturbance even if work occurs within 10 ft.

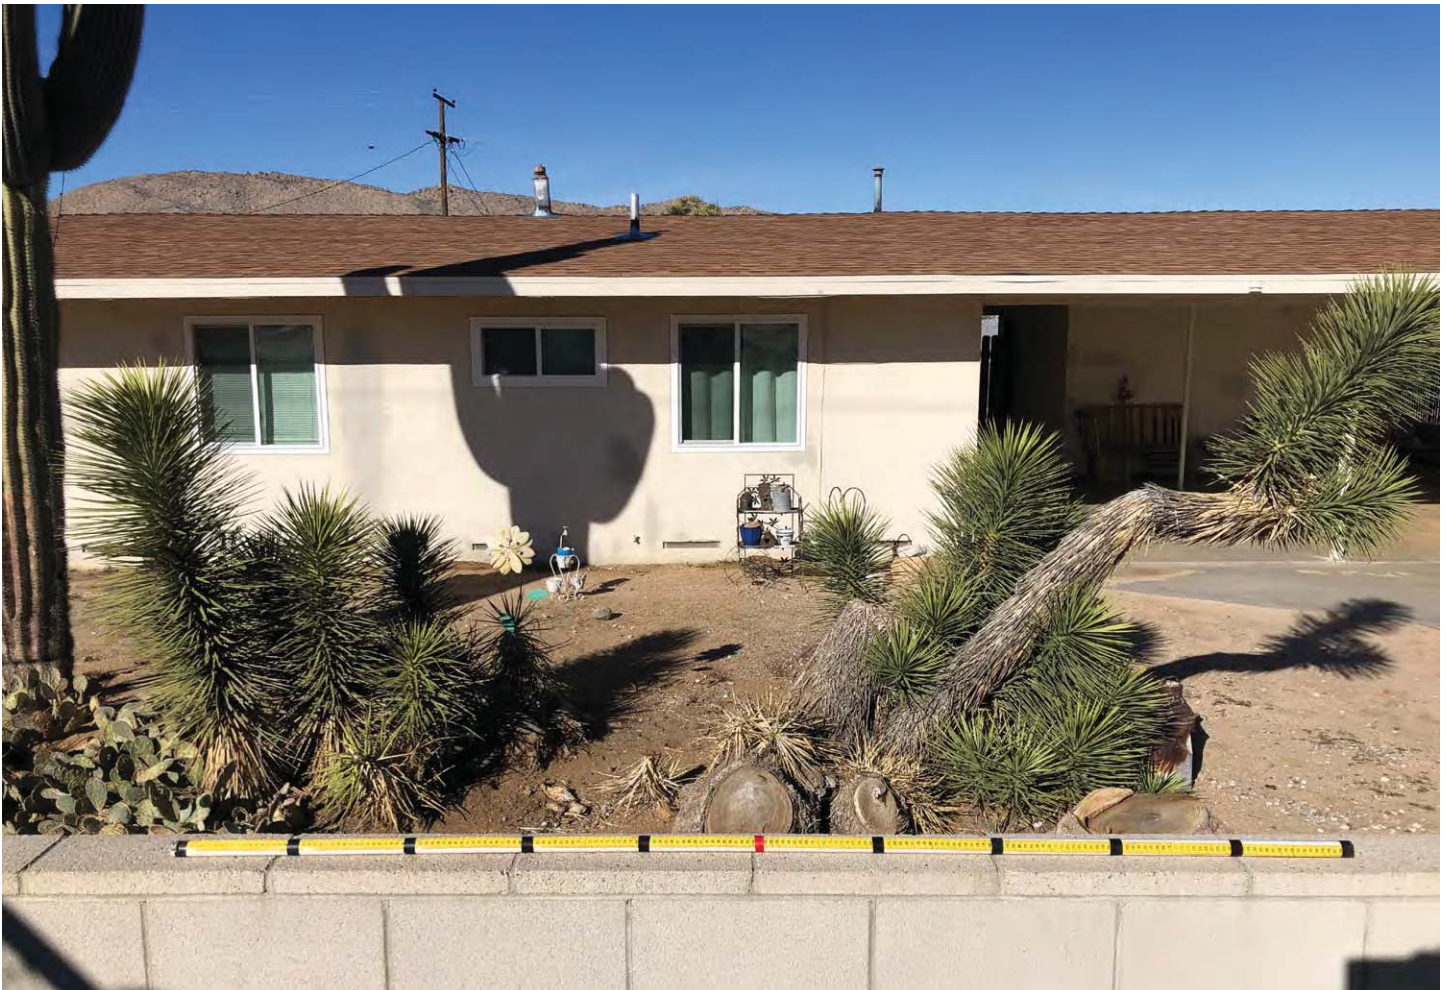
TRANSPLANT FEASIBILITY NOTES: Not recommended

OTHER NOTES & RECOMMENDATIONS: This assessment is general and approximate. There are at least 2 lives trees here and perhaps 1 dead. These trees may fall close to 10 ft of work, but are likely outside of that distance. Maintain 10 ft of distance from these trees. The Inspector indicated the wall is to stay and grading appears to be only a few inches, so impact should be insignificant. It is recommended to not alter the drainage significantly as they depend on the run off.

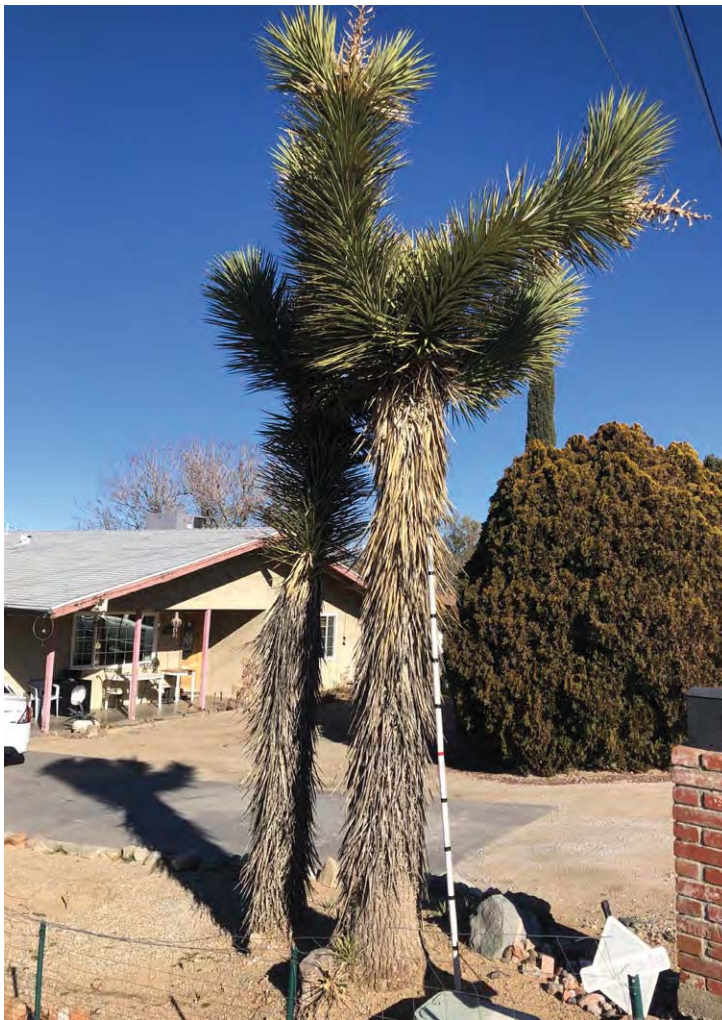
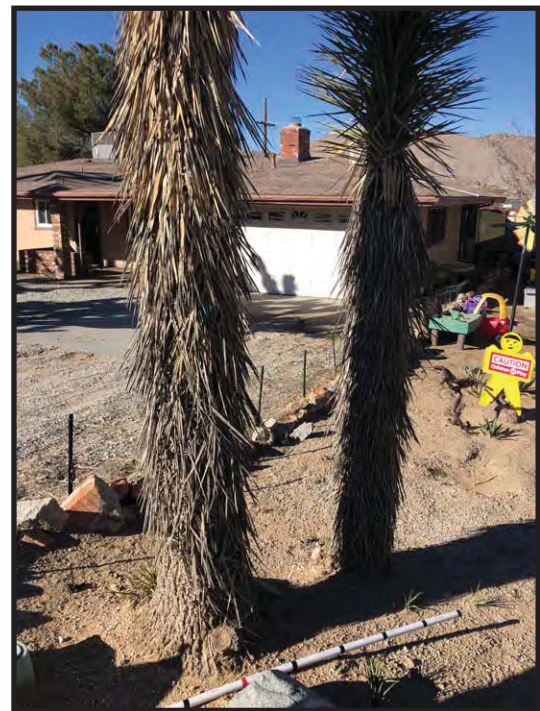
All pups within 1 meter of the main trunk

TRANSPLANT FEASIBILITY NOTES: Feasible given size and health. Best to keep all pups together, but if it may be difficult to keep root system in tract and separation maybe required, this will be determined in the field. There are many tiny pups which are best to transplant together. All small pups may need herbivore caging.

OTHER NOTES & RECOMMENDATIONS: If at all possible, given minimal depth of grading to leave in place and maintain distance off the drip line that would be preferred over transplanting.

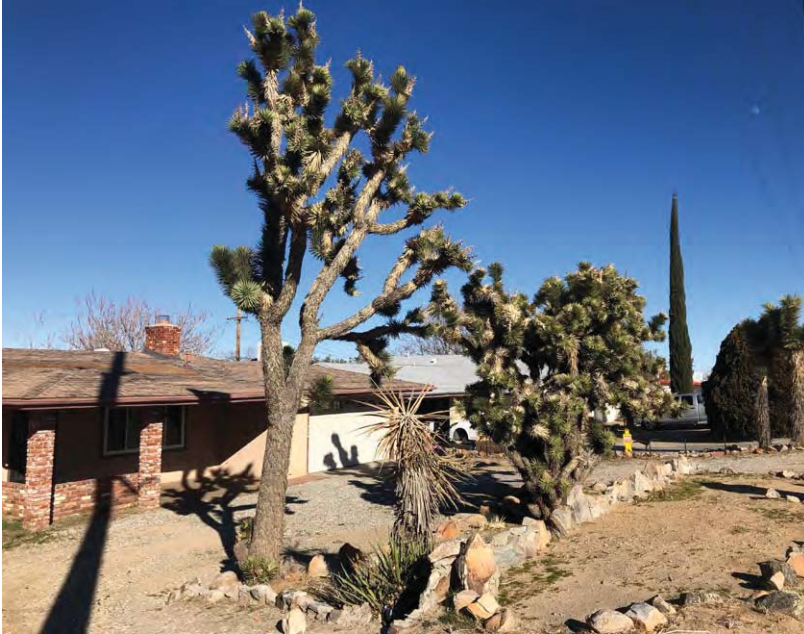
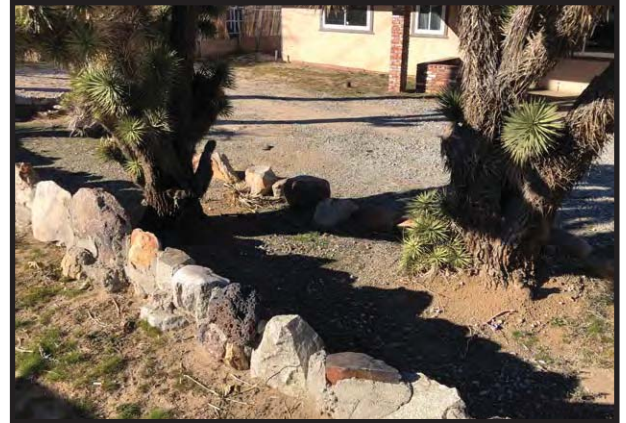
OTHER NOTES & RECOMMENDATIONS: We did not enter this property and thus these trees were not precisely measured. There may be 3-4 healthy trees in this lower driveway area behind the wall and it is hard to determine from afar. As long as the wall and grade stays relatively the same and the root systems are undisturbed to the north these trees should be fine. Grading appears minimal and actually may mostly be fill as opposed to cut. Avoid altering drainage in a way that erosion could bury the root flare. It should be no problem to maintain 10 ft of distance from these trees while conducting ground work, please confirm with the Inspector and contractors.

Trees 20 & 21 shown here and rough distance from the wall.

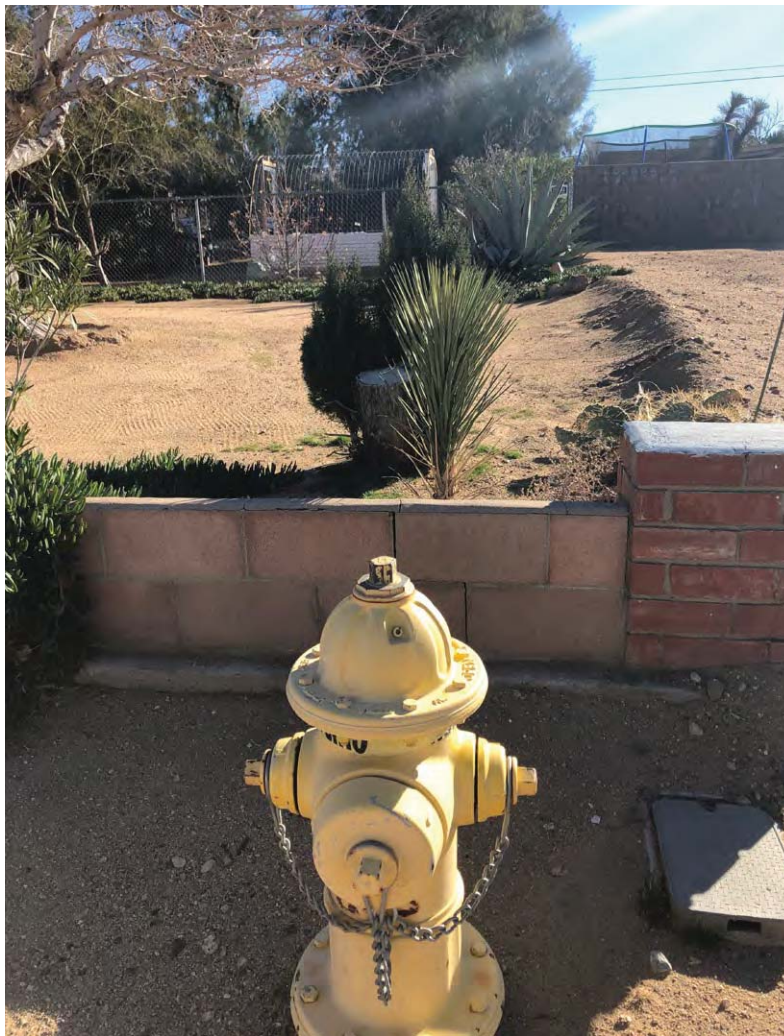
TRANSPLANT FEASIBILITY NOTES: Feasible, but may not be necessary.

OTHER NOTES & RECOMMENDATIONS: We did not enter this property and thus the tree were not precisely measured. The wall is to stay, but the plans indicate that the hydrant is to be relocated. Caution will be required when working on the hydrant to maintain distance from the tree where feasible. The town requires 10 ft of distance from the tree to conduct work. The hydrant may only be 6-7 ft from the tree. Town surveyor should resurvey this tree and hydrant to make sure work can comply. Since the tree is small and healthy, work could be conducted less than 10 ft as long as the drip line radius clearance is maintained and the wall is not removed.

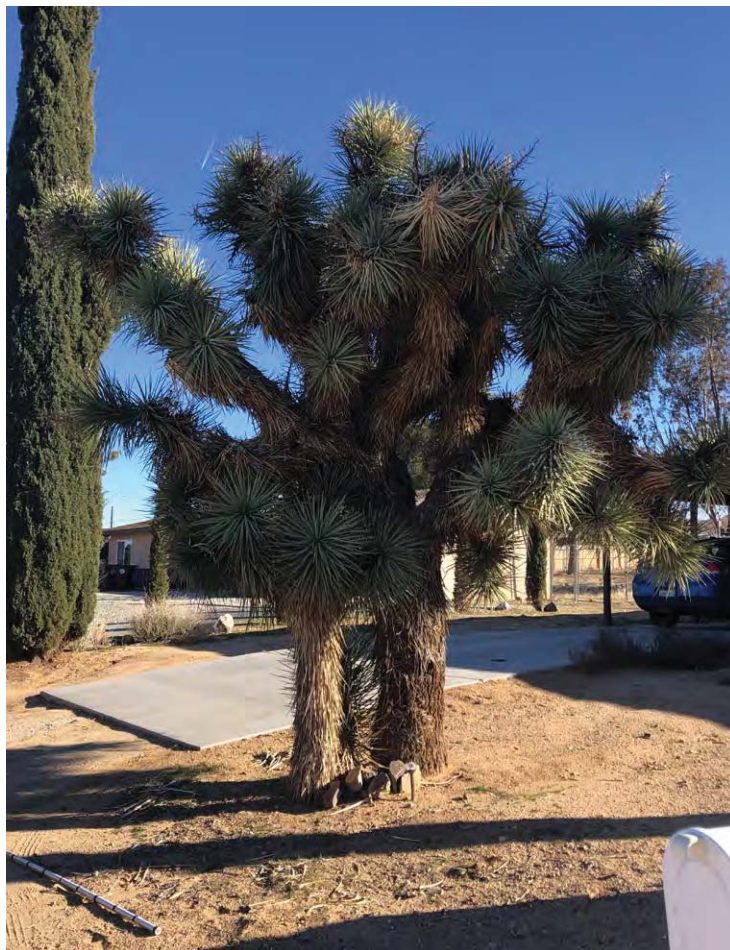
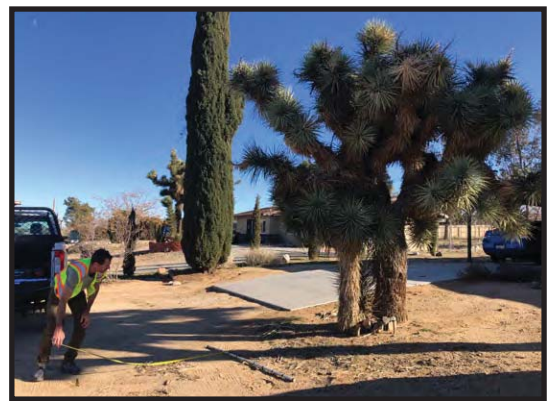
TRANSPLANT FEASIBILITY NOTES: Potentially feasible, but not recommended due to overall size and pups.

OTHER NOTES & RECOMMENDATIONS: Town requires a 10 ft radius (approx. 3 m), if possible to modify design to maintain 10 ft it would be best keep tree in place. This should be possible given the plans. This is a very healthy tree. Keep all work off the drip line radius. If possible to leave a large portion of the root system undisturbed, it may be preferable to disturb a small portion as opposed to destroying or attempting transplant. This plant flowered within the last two years and is contributing to the seed bank.

End of work should be able to maintain 10 ft from this tree.

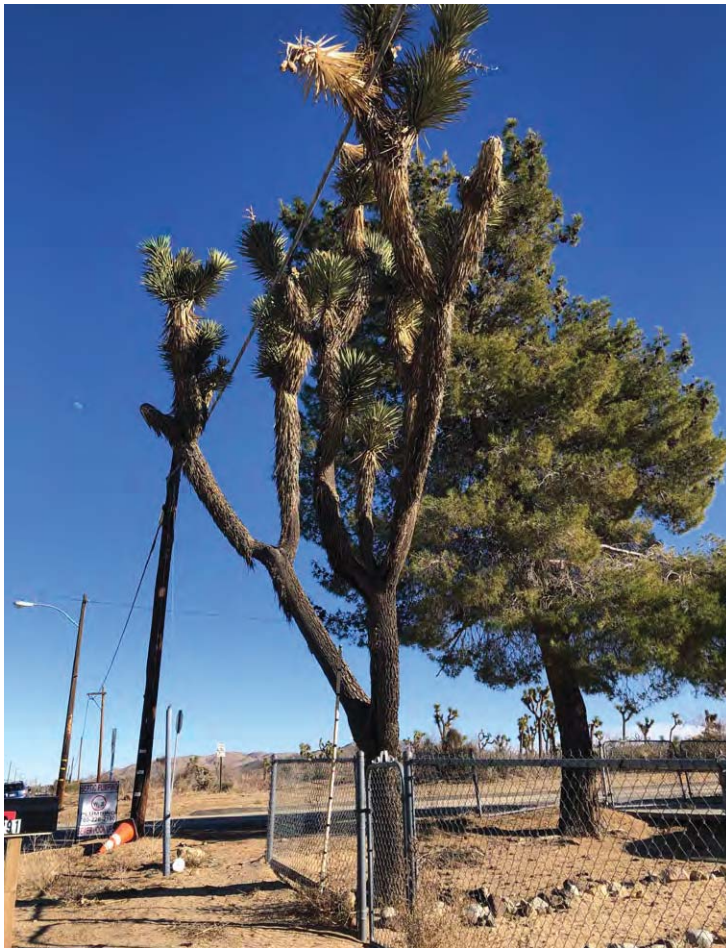
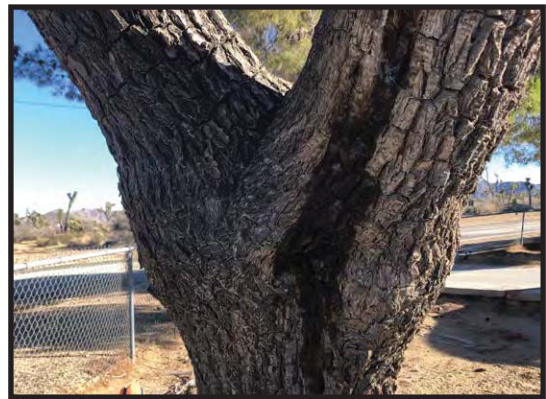
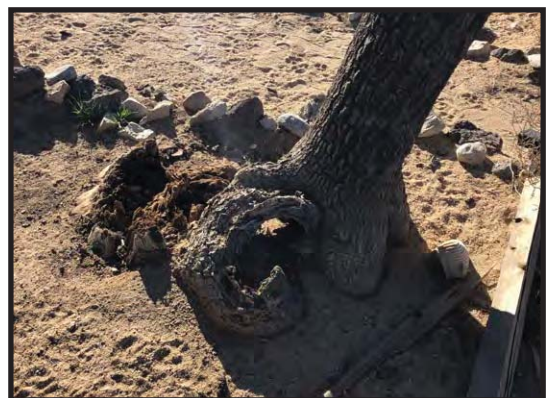
TRANSPLANT FEASIBILITY NOTES: Not recommended due to size and damages and proximity to power lines.

OTHER NOTES & RECOMMENDATIONS: Town requires a 10 ft radius (approx. 3 m), if possible to modify design to maintain 10 ft it would be best keep tree in place if possible to work around given the health condition of the tree. If possible to leave a large portion of the root system undisturbed, it may be preferable to disturb a small portion as opposed to destroying or attempting transplant. However, give damage to the base of the trunk, it could be possible that this tree may cause a public health hazard in the future. It is unknown if the prior road work had an affect on the root system of this tree since this is a corner property.
