GEOTECHNICAL INVESTIGATION  
PROPOSED SOUTH SIDE COMMUNITY PARK  
NWC JOSHUA LANE AND WARREN VISTA AVENUE  
YUCCA VALLEY, CALIFORNIA

Project No. 644-10019  
10-08-033

Project: Proposed 20 Acre South Side Community Park  
Town Project No. 8518-409  
Town of Yucca Valley  
San Bernardino County, California

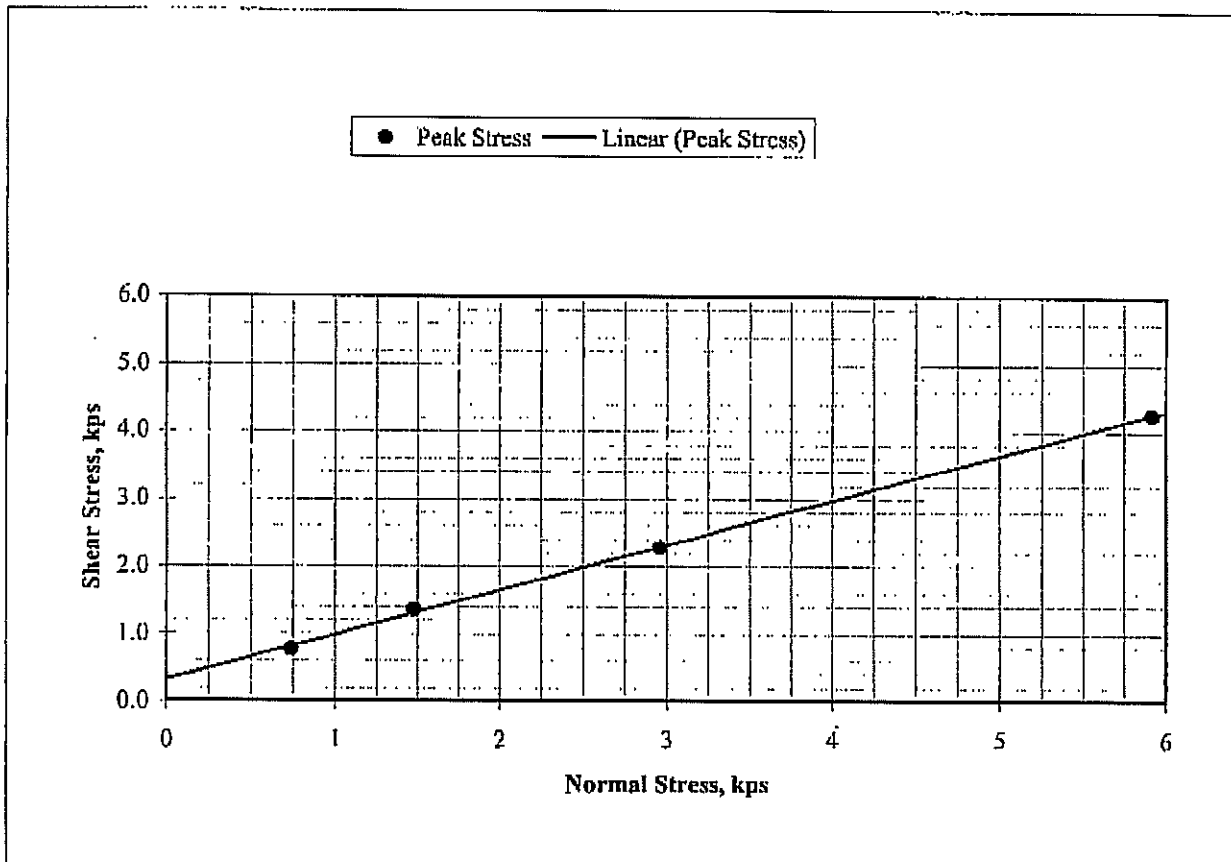
September 10, 2010  
Initial Dry Density: 120.8 pcf  
Initial Moisture Content: 7.1 %  
Peak Friction Angle ( $\phi$ ): 34°  
Cohesion (c): 320 psf

Test Results	1	2	3	4	Average
Moisture Content, %	12.6	12.6	12.6	12.6	12.6
Saturation, %	86.3	86.3	86.3	86.3	86.3
Normal Stress, kps	0.739	1.479	2.958	5.916	
Peak Stress, kps	0.768	1.360	2.281	4.254

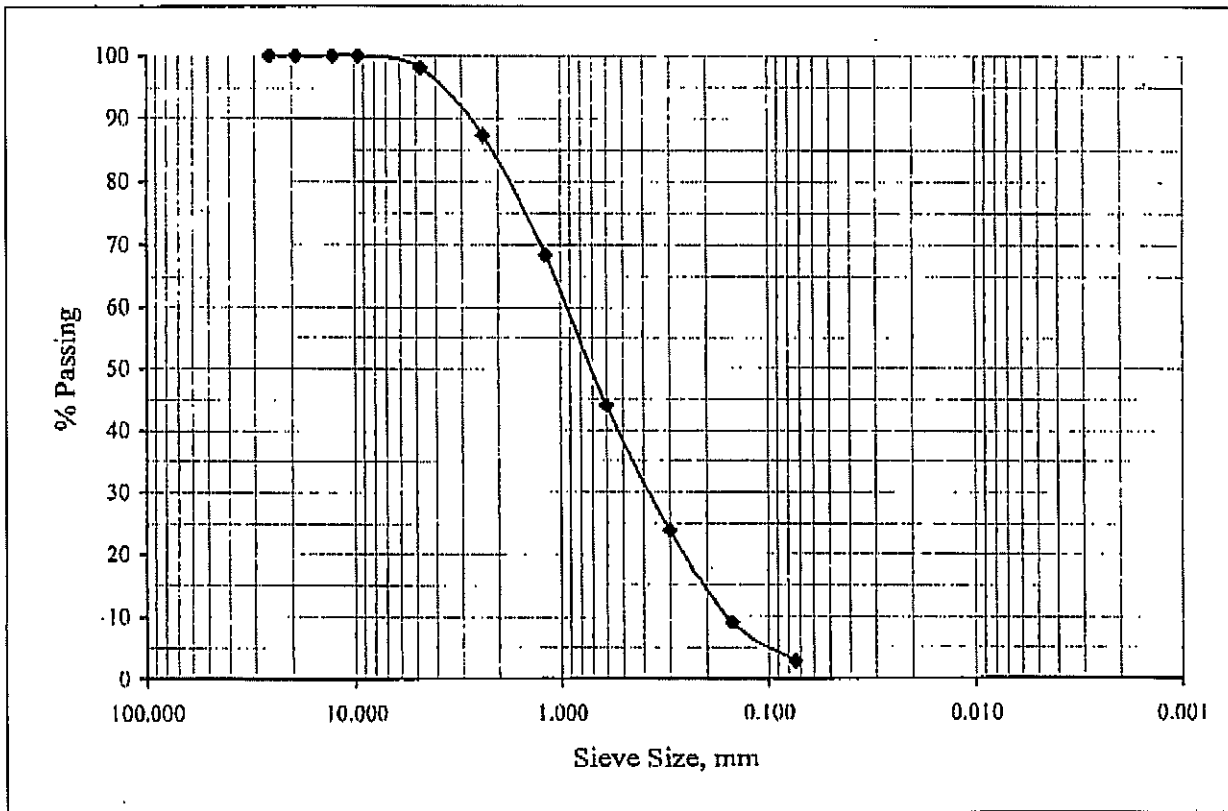
Soil Classification: SP-SM

Sieve Size, in	Sieve Size, mm	Percent Passing
1"	25.4	100.0
3/4"	19.1	100.0
1/2"	12.7	100.0
3/8"	9.53	100.0
#4	4.75	98.2
#8	2.36	87.4
#16	1.18	68.4
#30	0.60	44.0
#50	0.30	23.9
#100	0.15	9.0
#200	0.074	2.7

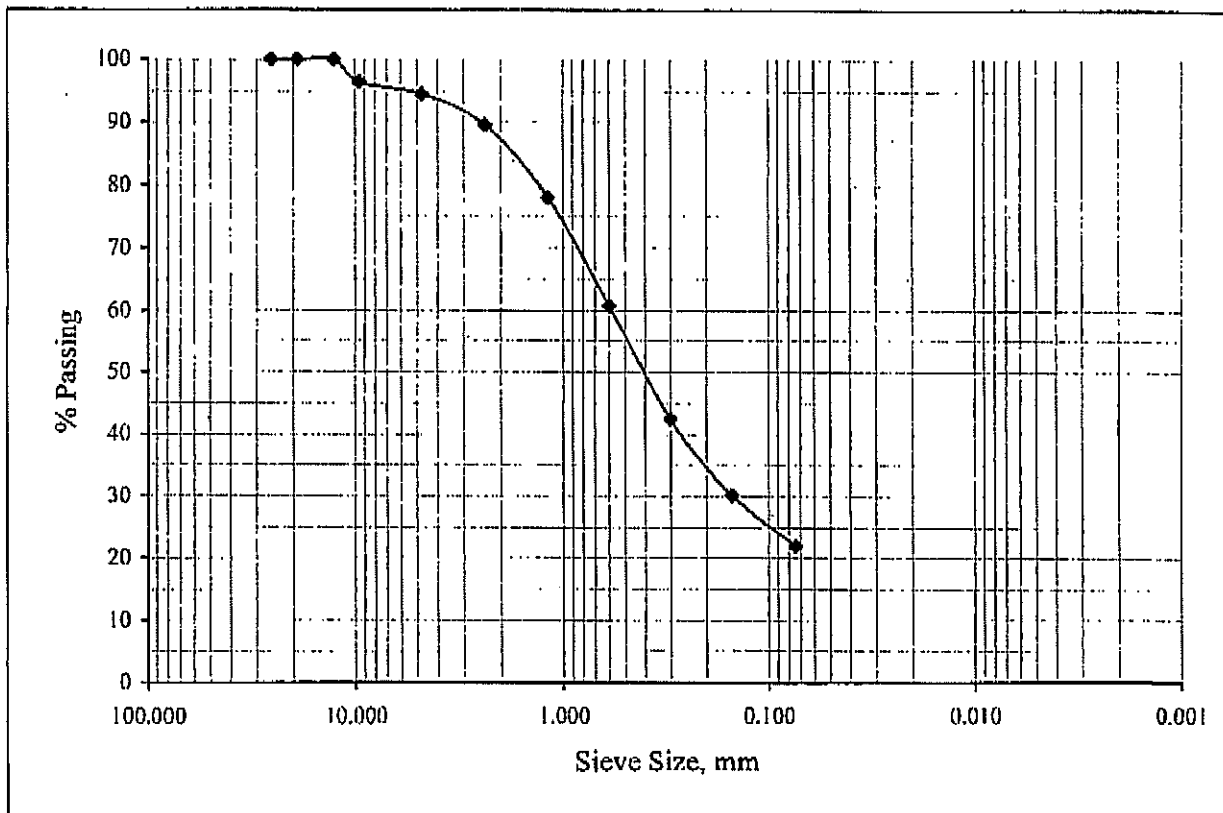
Soil Classification: SM

Sieve Size, in	Sieve Size, mm	Percent Passing
1"	25.4	100.0
3/4"	19.1	100.0
1/2"	12.7	100.0
3/8"	9.53	96.4
#4	4.75	94.5
#8	2.36	89.6
#16	1.18	78.1
#30	0.60	60.8
#50	0.30	42.3
#100	0.15	30.1
#200	0.074	22.0

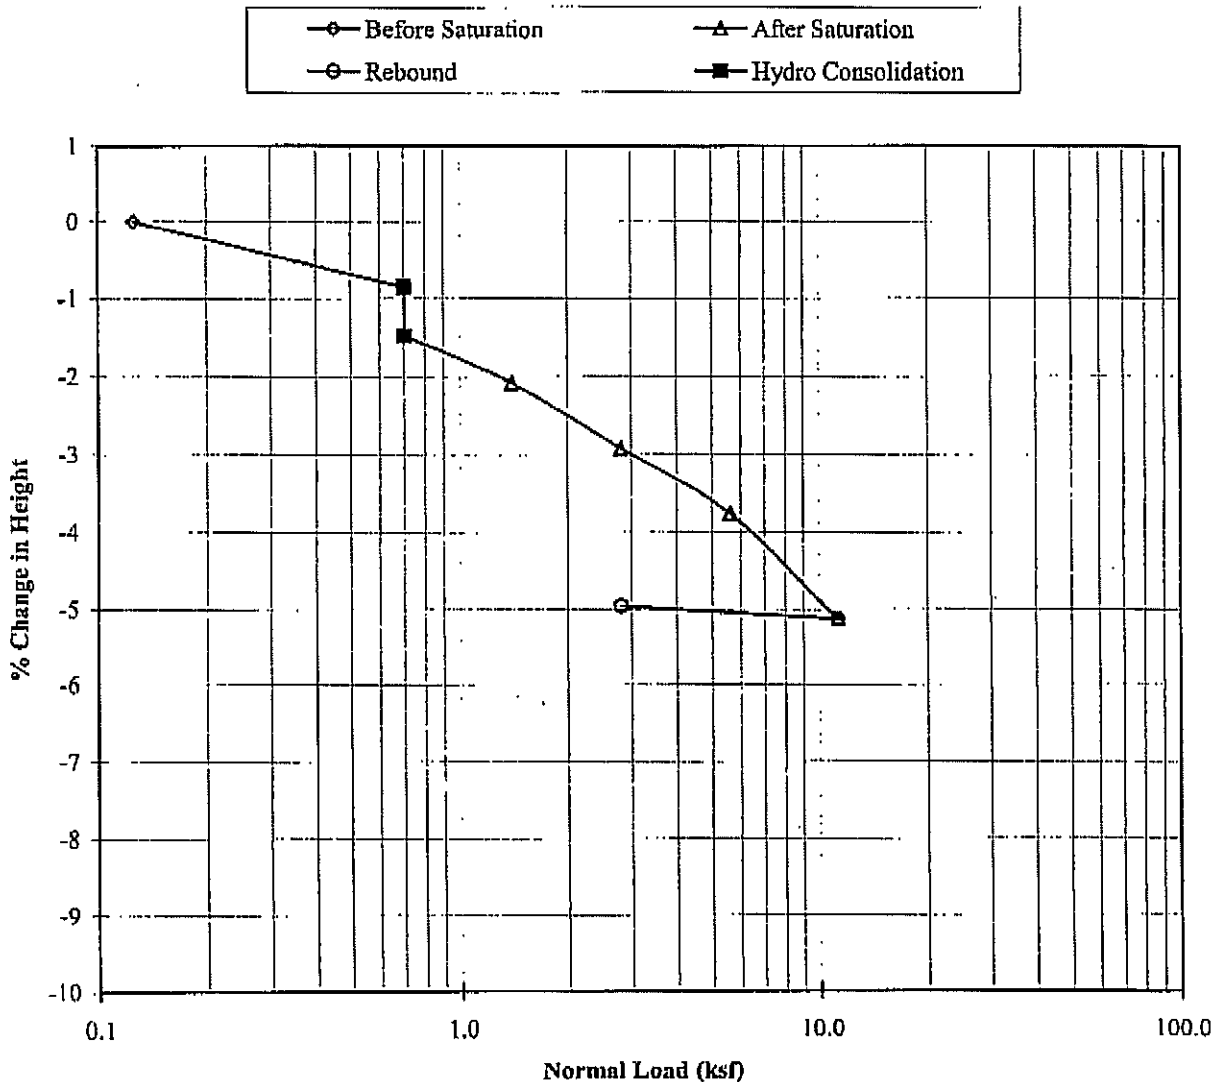
Hydrocollapse: 0.6% @ 0.702 ksf

% Change in Height vs Normal Pressure Diagram
