# 56695 Twentynine Palms Hwy Drainage Study

Town of Yucca Valley  
Public Works and Engineering Division  
Monterey Business Center  
58928 Business Center Drive  
Yucca Valley, CA 92284

DRP Enterprises  
PO Box 4428  
Palm Springs, CA 92263

Prepared: January 10, 2023

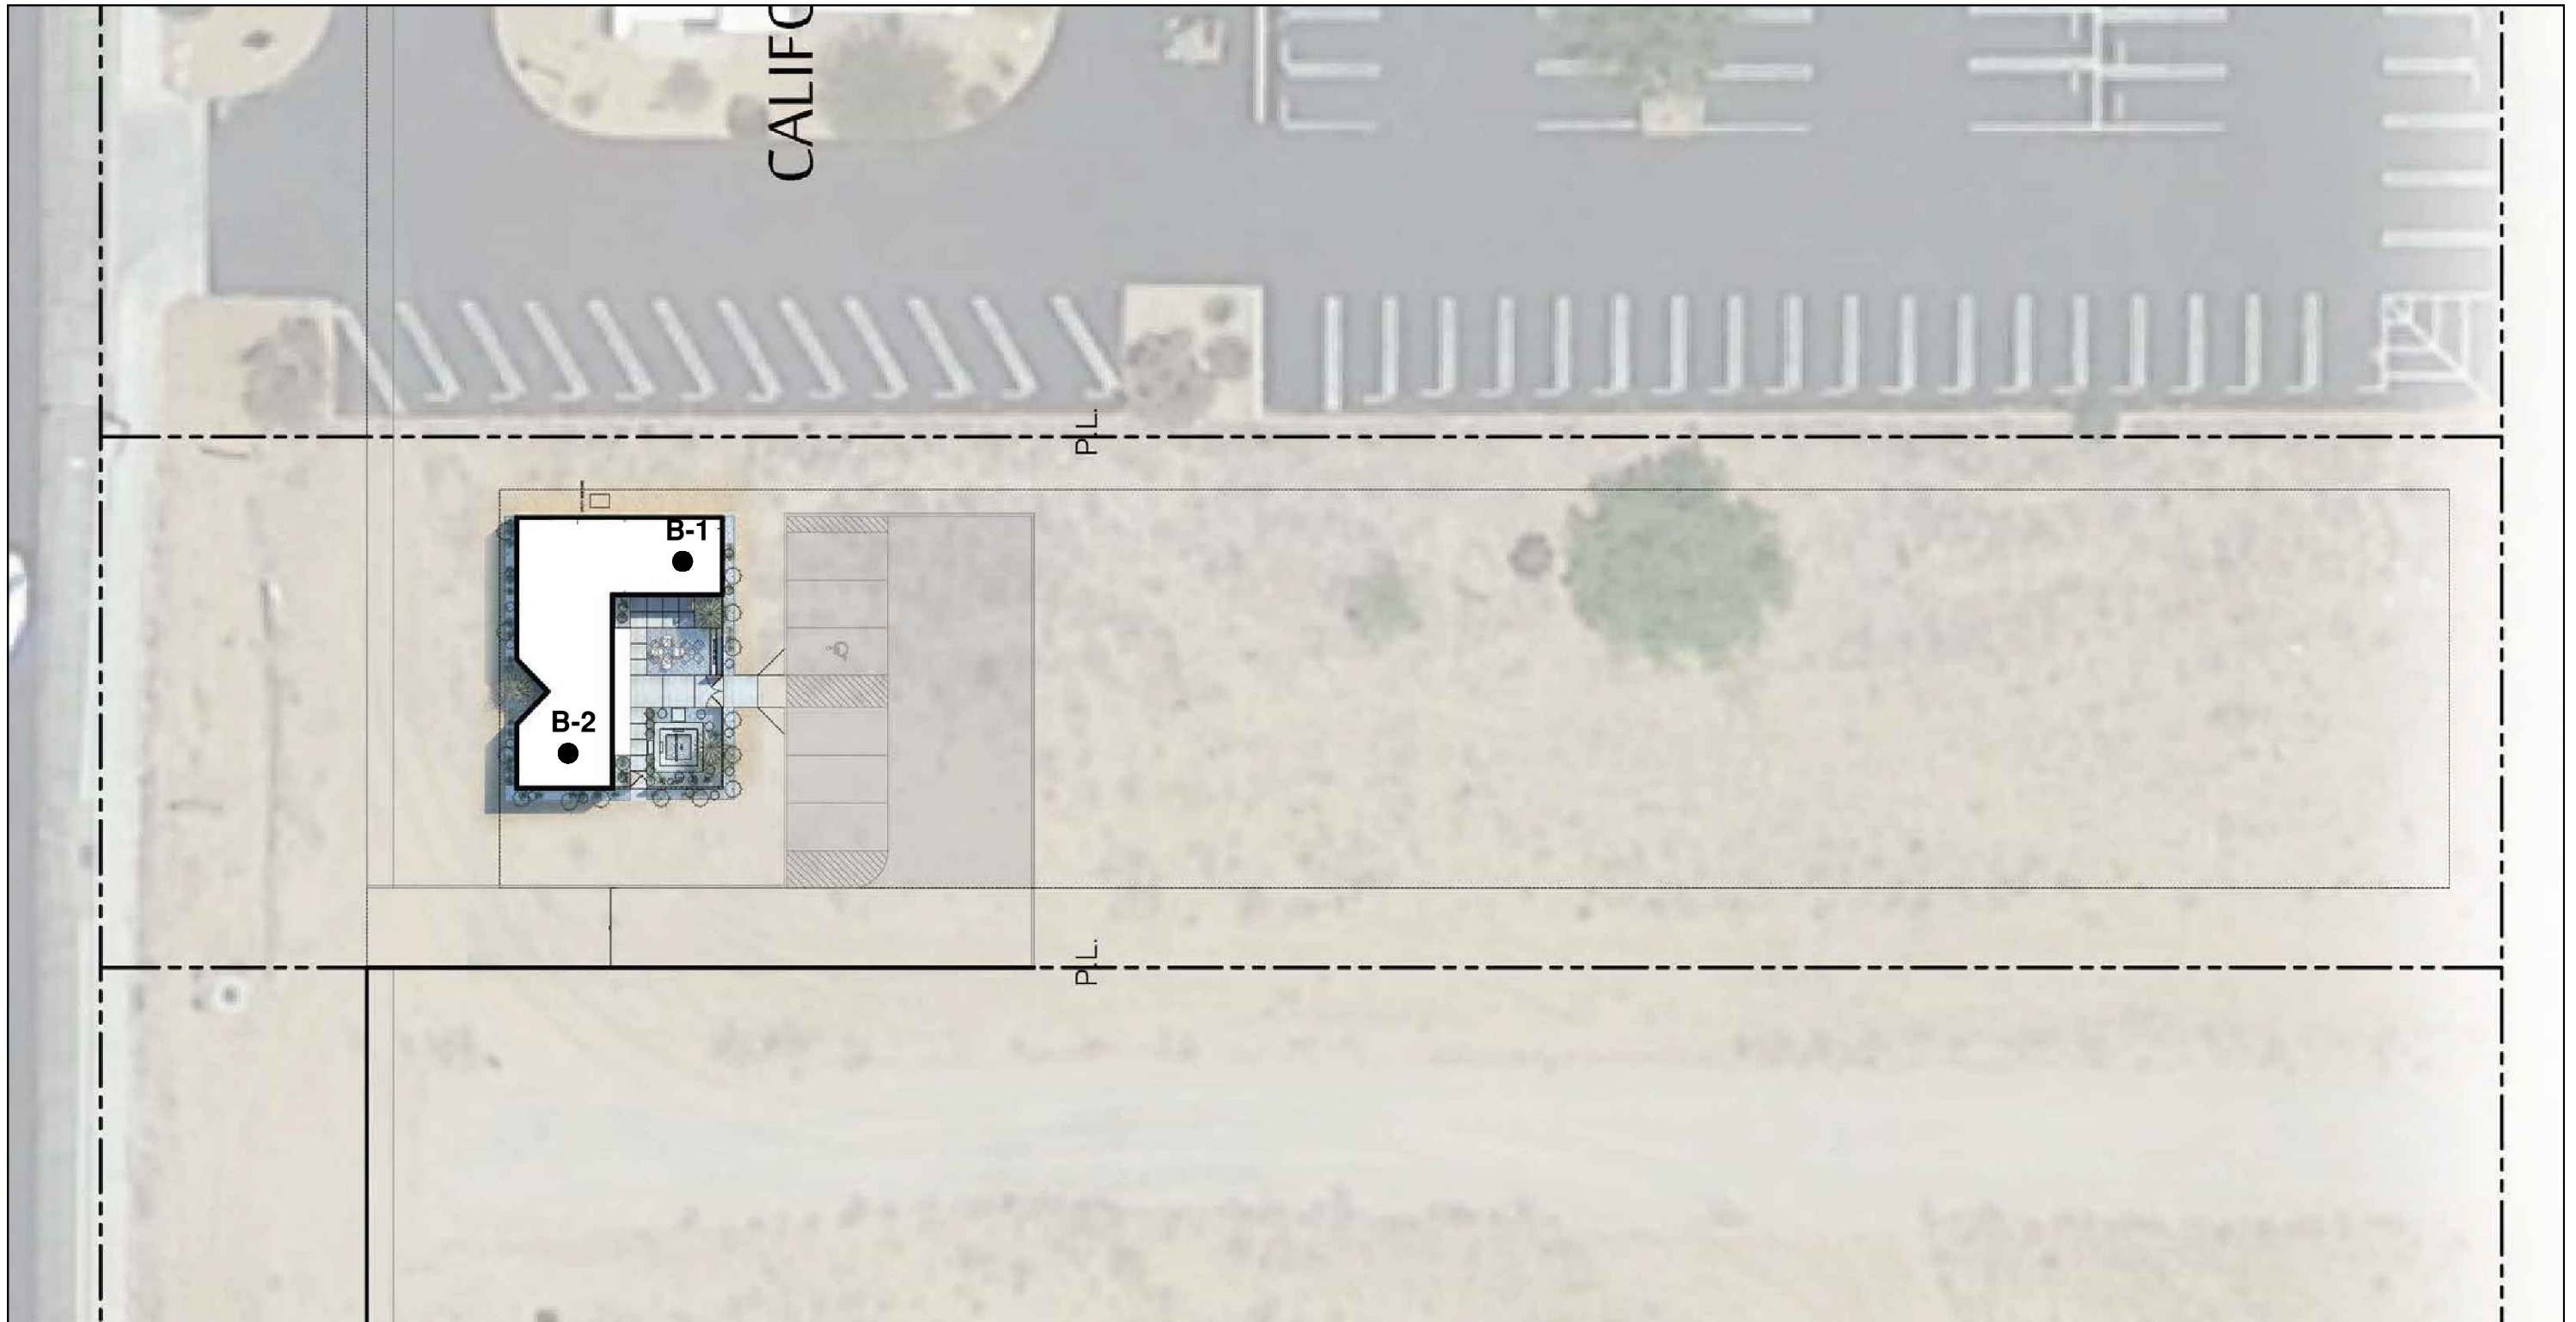
- B-1** ● APPROXIMATE LOCATION OF BORING

The subsurface conditions were evaluated on June 11, 2022 by advancing two (2) hand auger borings to maximum depth of 15 feet below the existing grade. The approximate location of the boring is shown on Plate 2 – Geotechnical Map. Detailed exploration information of soils boring is presented in Appendix A, Field Exploration.

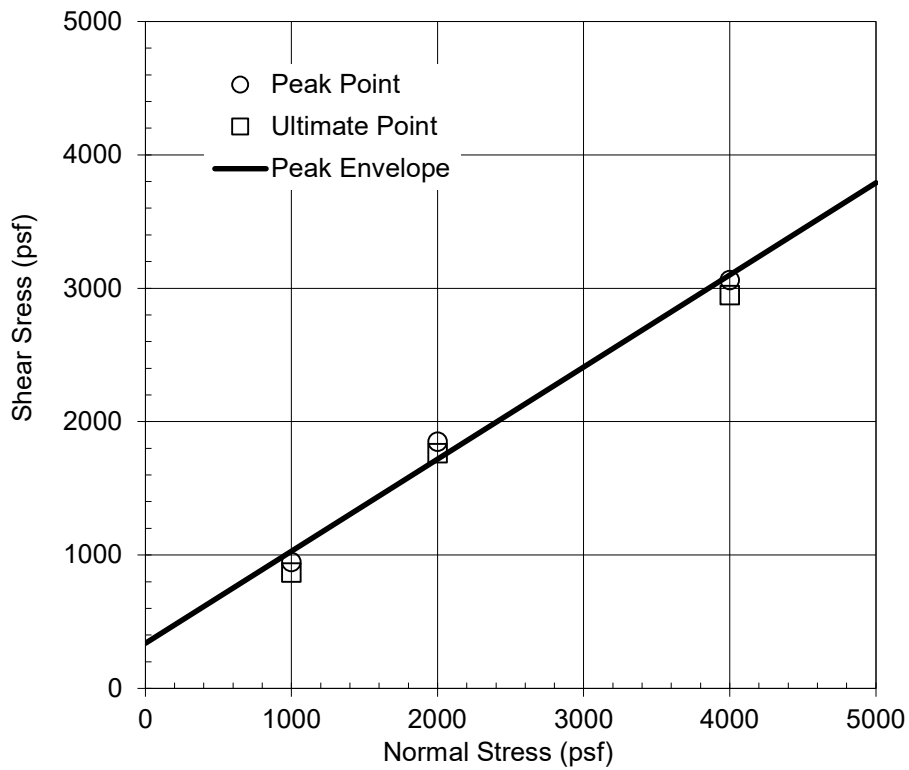
<b>Direct Shear Test Results</b>		Figure
	<b>50095 29 Palms Hwy</b>		<b>B-1</b>
Tech: LB			
Project # 22289

Strain Rate = 0.0118 inch/min				Interpreted Shear Strength			
Date Tested: 6/26/2022				Peak		Ultimate	
Boring No.	Sample No.	Depth	UCSC	Cohesion (psf)	Friction Angle (deg)	Cohesion (psf)	Friction Angle (deg)
B-1	1	2	SM	340	34.6	277	34.1
Sample description: Brown Silty Sand

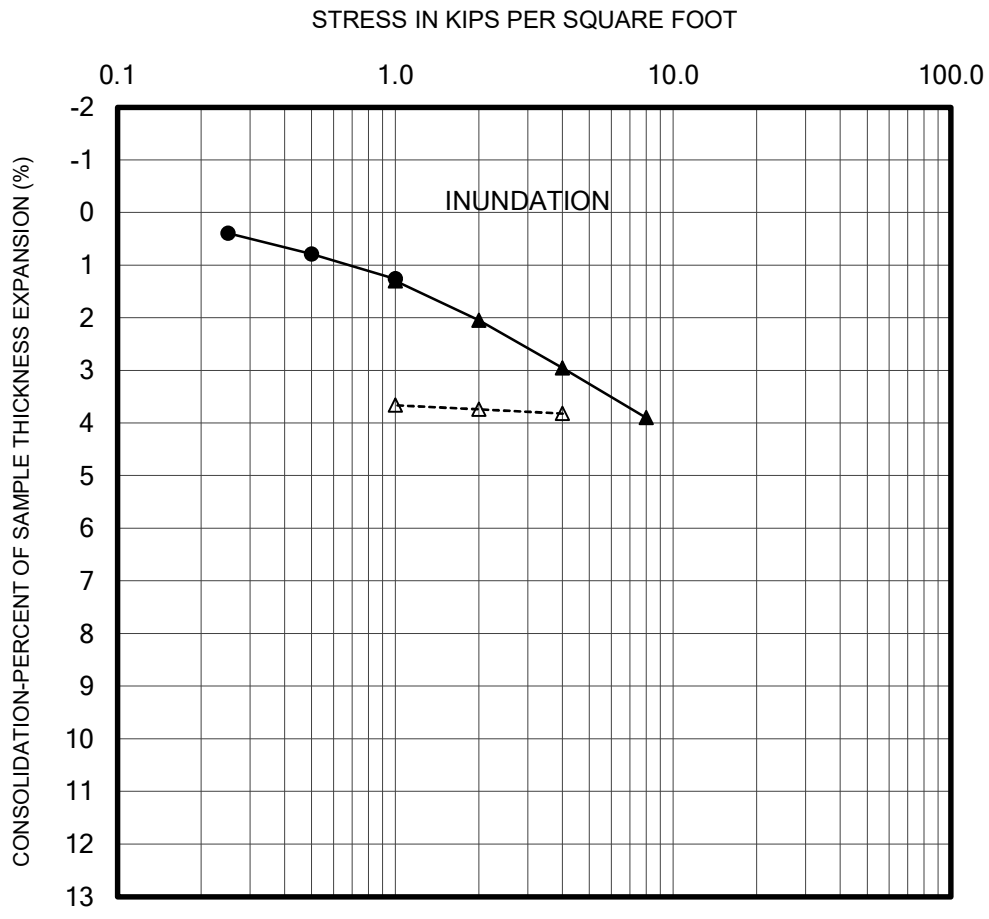
---●---	Seating Cycle	<b>Boring No.</b>	<b>B-1</b>
—●—	Loading Prior to Inundation	<b>Sample No.</b>	<b>2</b>
—▲—	Loading After Inundation	<b>Depth, ft.</b>	<b>5</b>
---△---	Rebound Cycle	<b>Sample Description</b>	<b>Brown Silty Sand w/ Gravel</b>
Date Tested: 26-Jun			
PERFORMED IN GENERAL ACCORDANCE WITH ASTM D 2435
